Access Compliance Report

Public Rights-of-Way

(Curb Ramps)

Intersection ID: 27333	Main Street: BALLANTYNE_MEDICAL_PL	Cross Street: N/A	Location: SE
ADA ID: 83F50F913FEB	Ramp Type: Perp	Initial Pass/Fail: Fail	Overall Compliance: No
Codes/Mitigation Info/Possible Solution		Field Measurements/Component Compliance	
Severity Score: 12.5

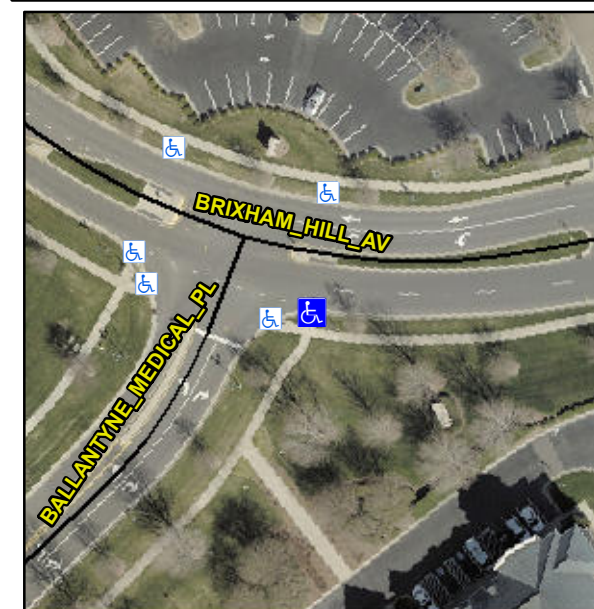
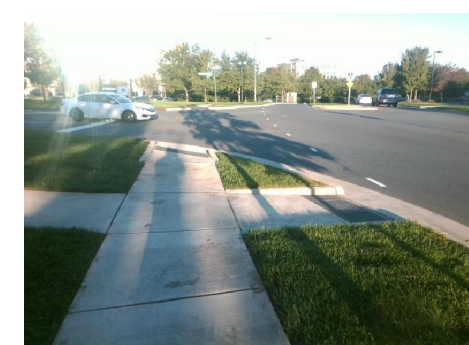
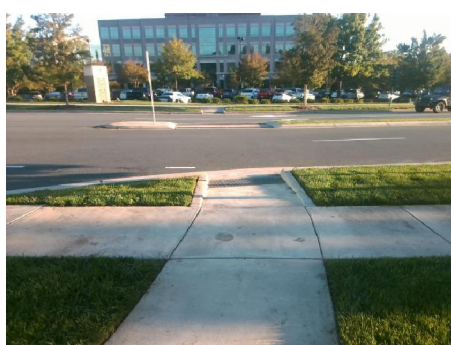
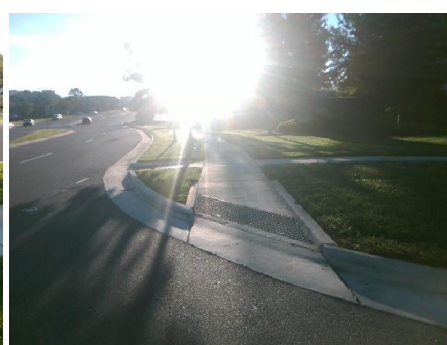
Not Found, R304.2.2

Compliance	Description	Data	Compliance	Description	Data
N/A	Ramp Length (in)	76.0	No	Ramp Slope (%)	8.9
Yes	Ramp Width (in)	59.0	Yes	Ramp XSlope (%)	1.4
N/A	Flare Type LT	N/A	N/A	Flare Type RT	N/A
N/A	Flare Slope LT (%)	N/A	N/A	Flare Slope RT (%)	N/A
N/A	Flare Traversable LT?	N/A	N/A	Flare Traversable RT?	N/A
N/A	Landing Length (in)	N/A	N/A	DWS Provided?	N/A
N/A	Landing Width (in)	N/A	N/A	DWS Contrast?	N/A
N/A	Landing Slope (%)	N/A	N/A	DWS Length (in)	N/A
N/A	Landing X Slope (%)	N/A	N/A	DWS Full Width?	N/A
N/A	Landing Curb? (Y/N)	N/A	N/A	DWS Offset (in)	N/A
N/A	Shared Landing?	N/A			
N/A	Gutter Ponding?	N/A	N/A	Gutter Slope (%)	N/A
N/A	Gutter Lip Ht (in)	N/A	N/A	Gutter X Slope (%)	N/A
N/A	Painted X Walk1?	No	N/A	Painted X Walk2?	N/A
	X Walk 1 Direction	To N		X Walk 2 Direction	N/A
N/A	X Walk 1 Width (in)	N/A	N/A	X Walk 2 Width (in)	N/A
	X Walk 1 Slope (%)	1.4		X Walk 2 Slope (%)	N/A
	X Walk 1 X Slope (%)	1.0		X Walk 2 X Slope (%)	N/A

N/A	Ramp inside XWalk1?	N/A	N/A	Ramp inside XWalk2?	N/A
	Road Slope (%)	N/A	N/A	Clear Space?	N/A
	Road X Slope (%)	N/A	N/A	Clear Space to XWalk (in)	N/A
N/A	Any Obstructions?	N/A	N/A	Storm Grate/Utility Hazard?	N/A
	Obstruction Type			Storm Grate/Utility Type	
		N/A			N/A
			Yes	Surface Condition? (G/P)	Good

Possible Solutions:

Remove & Replace Entire Ramp.

Total Cost: \$ 1850.00
