## Access Compliance Report Public Rights-of-Way (Curb Ramps)

Intersection ID: 12426 Main Street: KENWOOD\_AV Cross Street: MIDWOOD\_PL Location: SE

ADA ID: 83FB84719BF1 Ramp Type: Perp Initial Pass/Fail: Fail Overall Compliance: No Severity Score: 12.5

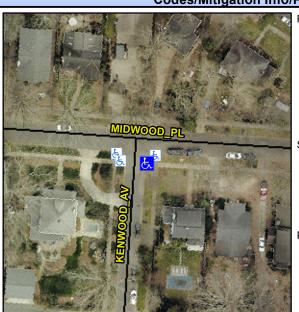
Field Measurements/Component Compliance							
Compl	iance Description	Data	Comp	liance Description	Data		
N/A	Ramp Length (in)	56.0	No	Ramp Slope (%)	11.7		
Yes	Ramp Width (in)	60.0	Yes	Ramp XSlope (%)	1.7		
N/A	Flare Type LT	N/A	N/A	Flare Type RT	N/A		
N/A	Flare Slope LT (%)	N/A	N/A	Flare Slope RT (%)	N/A		
N/A	Flare Traversable LT?	N/A	N/A	Flare Traversable RT?	N/A		
N/A	Landing Length (in)	N/A	N/A DWS Provided?		N/A		
N/A	Landing Width (in)	N/A	N/A	N/A DWS Contrast?			
N/A	Landing Slope (%)	N/A	N/A	DWS Length (in)	N/A		
N/A	Landing X Slope (%)	N/A	N/A	DWS Full Width?	N/A		
N/A	Landing Curb? (Y/N)	N/A	N/A	DWS Offset (in)	N/A		
N/A	Shared Landing?	N/A					
N/A	Gutter Ponding?	N/A	N/A	Gutter Slope (%)	N/A		
N/A	Gutter Lip Ht (in)	N/A	N/A	Gutter X Slope (%)	N/A		
N/A	Painted X Walk1?	No	N/A	Painted X Walk2?	N/A		
	X Walk 1 Direction	To W		X Walk 2 Direction	N/A		
N/A	X Walk 1 Width (in)	N/A	N/A	I/A X Walk 2 Width (in)

X Walk 1 Slope (%)	1.2		X Walk 2 Slope (%)	N/A		
	X Walk 1 X Slope (%)	0.3		X Walk 2 X Slope (%)	N/A		
N/A	Ramp inside XWalk1?	N/A	N/A	Ramp inside XWalk2?	N/A		
	Road Slope (%)	N/A	N/A	Clear Space?	N/A		
	Road X Slope (%)	N/A	N/A	Clear Space to XWalk (in)	N/A		
N/A	Any Obstructions?	N/A	N/A	Storm Grate/Utility Hazard?	N/A		
	Obstruction Type			Storm Grate/Utility Type			
		N/A			N/A		
			Yes	Surface Condition? (G/P)	Good

1 CCCIDIC CCIGLICII	
Possible Solutions:	Com
Remove & Replace Entire Ramp.	N/A
	Yes
	N/A
	N/A
	N/A
	N/A
Surveyor Notes:	N/A
N/A	N/A
	N/A
	N/A
	N/A
PROW/ADA:	N/A
R304.2.2	N/A
	N/A
	N/A
	N/A
