Access Compliance Report

Public Rights-of-Way

(Curb Ramps)

Intersection ID: N/A	Main Street: ELGIN_MOOR_RD	Cross Street: LANGWELL_LN	Location: NE
ADA ID: 840C12AE2D53	Ramp Type: Perp	Initial Pass/Fail: Fail	Overall Compliance: No
Codes/Mitigation Info/Possible Solution		Field Measurements/Component Compliance

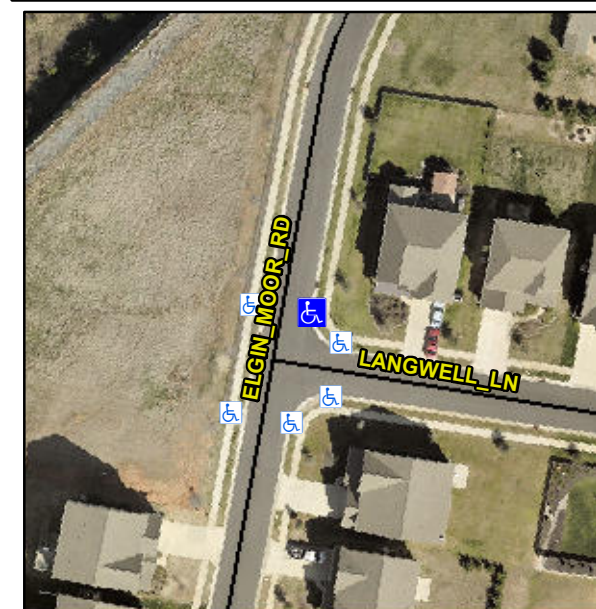
Not Found, R304.2.2, R304.5.3

Compliance	Description	Data	Compliance	Description	Data
N/A	Ramp Length (in)	47.0	No	Ramp Slope (%)	8.6
Yes	Ramp Width (in)	48.0	No	Ramp XSlope (%)	4.9
N/A	Flare Type LT	N/A	N/A	Flare Type RT	N/A
N/A	Flare Slope LT (%)	N/A	N/A	Flare Slope RT (%)	N/A
N/A	Flare Traversable LT?	N/A	N/A	Flare Traversable RT?	N/A
N/A	Landing Length (in)	N/A	N/A	DWS Provided?	N/A
N/A	Landing Width (in)	N/A	N/A	DWS Contrast?	N/A
N/A	Landing Slope (%)	N/A	N/A	DWS Length (in)	N/A
N/A	Landing X Slope (%)	N/A	N/A	DWS Full Width?	N/A
N/A	Landing Curb? (Y/N)	N/A	N/A	DWS Offset (in)	N/A
N/A	Shared Landing?	N/A			
N/A	Gutter Ponding?	N/A	N/A	Gutter Slope (%)	N/A
N/A	Gutter Lip Ht (in)	N/A	N/A	Gutter X Slope (%)	N/A
N/A	Painted X Walk1?	No	N/A	Painted X Walk2?	N/A
	X Walk 1 Direction	To NW		X Walk 2 Direction	N/A
N/A	X Walk 1 Width (in)	N/A	N/A	X Walk 2 Width (in)	N/A
	X Walk 1 Slope (%)	1.4		X Walk 2 Slope (%)	N/A
	X Walk 1 X Slope (%)	3.6		X Walk 2 X Slope (%)	N/A

N/A	Ramp inside XWalk1?	N/A	N/A	Ramp inside XWalk2?	N/A
	Road Slope (%)	N/A	N/A	Clear Space?	N/A
	Road X Slope (%)	N/A	N/A	Clear Space to XWalk (in)	N/A
N/A	Any Obstructions?	N/A	N/A	Storm Grate/Utility Hazard?	N/A
	Obstruction Type			Storm Grate/Utility Type	
		N/A			N/A
			Yes	Surface Condition? (G/P)	Good

Possible Solutions:

Remove & Replace Entire Ramp.

Total Cost: \$ 1850.00
