# Access Compliance Report

## Public Rights-of-Way

### (Curb Ramps)

Intersection ID: N/A	Main Street: BIRNEN_DR	Cross Street: RENISTON_DR	Location: NW
ADA ID: 8416285BC616	Ramp Type: Perp	Initial Pass/Fail: Fail	Overall Compliance: No
			Severity Score: 13.75

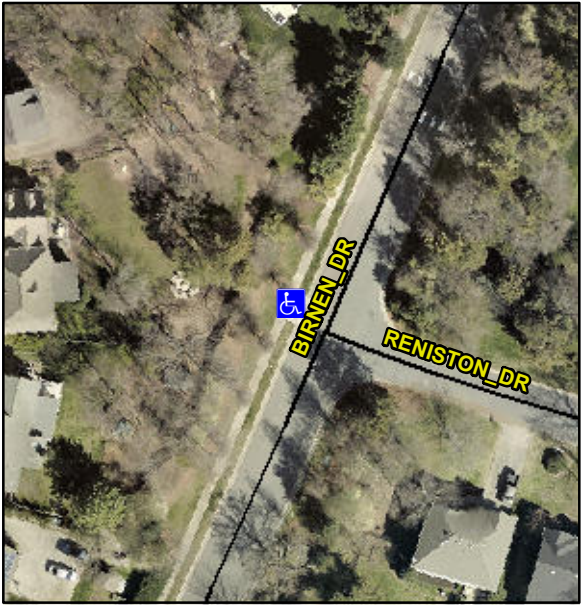
Possible Solutions:		<b>Compliance</b>	<b>Description</b>	<b>Data</b>
	Remove & Replace Entire Ramp.		N/A	Ramp Length (in)	59.0
			Yes	Ramp Width (in)	48.0
			N/A	Flare Type LT	N/A
			N/A	Flare Slope LT (%)	N/A
			N/A	Flare Traversable LT?	N/A
			N/A	Landing Length (in)	N/A
			N/A	Landing Width (in)	N/A
			N/A	Landing Slope (%)	N/A
			N/A	Landing X Slope (%)	N/A
<p>Surveyor Notes:</p> <p>N/A</p> <p>PROW/ADA:</p> <p>Not Found, R304.2.2, R304.5.3</p>			N/A	Flare Type RT	N/A
			N/A	Flare Slope RT (%)	N/A
			N/A	Flare Traversable RT?	N/A
			N/A	DWS Provided?	N/A
			N/A	DWS Contrast?	N/A
			N/A	DWS Length (in)	N/A
			N/A	DWS Full Width?	N/A
			N/A	DWS Offset (in)	N/A
			N/A	Shared Landing?	N/A
			N/A	Gutter Ponding?	N/A
			N/A	Gutter Lip Ht (in)	N/A
			N/A	Painted X Walk1?	No
				X Walk 1 Direction	To SE
			N/A	X Walk 1 Width (in)	N/A

X Walk 1 Slope (%)	3.2
				X Walk 1 X Slope (%)	3.8
			N/A	Ramp inside XWalk1?	N/A
			N/A	Road Slope (%)	N/A
			N/A	Road X Slope (%)	N/A
			N/A	Any Obstructions?	N/A
				Obstruction Type	
Total Cost:		\$ 1850.00			
			N/A		N/A
			Yes	Surface Condition? (G/P)	Good
