Intersection ID: 10116	Main Street: MILL_RD	Cross Street: SOLOMON_ST	Location:	SE
ADA ID: 841B92411A6A	Ramp Type: Perp	Initial Pass/Fail: Fail	Overall Compliance: No	Severity Score: 13.75

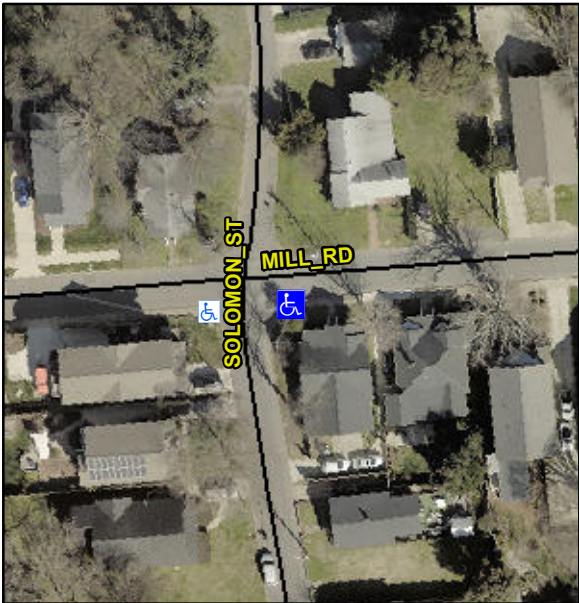
<div>Street 1 Name Stop Condition-Street 2 Street 2 Name Stop Condition-Street 1</div>	<div>Possible Solutions:</div> <div>Remove & Replace Entire Ramp.</div>			Compliance	Description	Data	Compliance	Description	Data
				N/A	Ramp Length (in)	38.0	No	Ramp Slope (%)	11.4
				Yes	Ramp Width (in)	48.0	No	Ramp XSlope (%)	2.2
				N/A	Flare Type LT	N/A	N/A	Flare Type RT	N/A
				N/A	Flare Slope LT (%)	N/A	N/A	Flare Slope RT (%)	N/A
	<div>Surveyor Notes:</div> <div>N/A</div> <div>PROW/ADA: R304.2.2, R304.5.3</div>			N/A	Flare Traversable LT?	N/A	N/A	Flare Traversable RT?	N/A
				N/A	Landing Length (in)	N/A	N/A	DWS Provided?	N/A
				N/A	Landing Width (in)	N/A	N/A	DWS Contrast?	N/A
				N/A	Landing Slope (%)	N/A	N/A	DWS Length (in)	N/A
				N/A	Landing X Slope (%)	N/A	N/A	DWS Full Width?	N/A
			N/A	Landing Curb? (Y/N)	N/A	N/A	DWS Offset (in)	N/A

N/A	Shared Landing?	N/A				
			N/A	Gutter Ponding?	N/A	N/A	Gutter Slope (%)	N/A	
			N/A	Gutter Lip Ht (in)	N/A	N/A	Gutter X Slope (%)	N/A	
			N/A	Painted X Walk1?	No	N/A	Painted X Walk2?	N/A	
				X Walk 1 Direction	To W		X Walk 2 Direction	N/A	
			N/A	X Walk 1 Width (in)	N/A	N/A	X Walk 2 Width (in)	N/A	
				X Walk 1 Slope (%)	3.9		X Walk 2 Slope (%)	N/A	
				X Walk 1 X Slope (%)	1.5		X Walk 2 X Slope (%)	N/A	
			N/A	Ramp inside XWalk1?	N/A	N/A	Ramp inside XWalk2?	N/A	
				Road Slope (%)	N/A	N/A	Clear Space?	N/A	
				Road X Slope (%)	N/A	N/A	Clear Space to XWalk (in)	N/A	
			N/A	Any Obstructions?	N/A	N/A	Storm Grate/Utility Hazard?	N/A	
				Obstruction Type			Storm Grate/Utility Type		
					N/A			N/A	
						Yes	Surface Condition? (G/P)	Good
