# Access Compliance Report

## Public Rights-of-Way

### (Curb Ramps)

| Intersection ID: N/A | Main Street: BRECKFIELD_CT | Cross Street: HALKIRK_MANOR_LN | Location: SW |

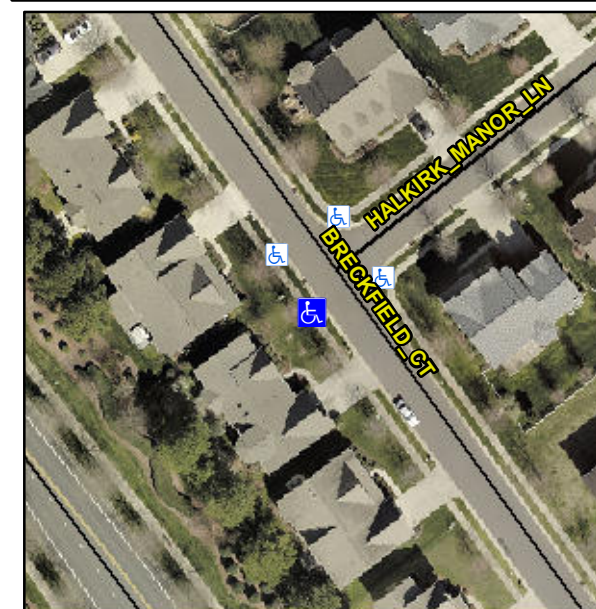
| Severity Score: 21.25 | | | |

**Not Found, R304.5.1, R304.2.2**

| Compliance | Description | Data | Compliance | Description | Data |
|---|---|---|---|---|---|
| N/A | Ramp Length (in) | 48.0 | No | Ramp Slope (%) | 10.7 |
| No | Ramp Width (in) | 47.0 | Yes | Ramp XSlope (%) | 1.5 |

Possible Solutions:

**Remove & Replace Entire Ramp.**

Total Cost: \$ 1850.00

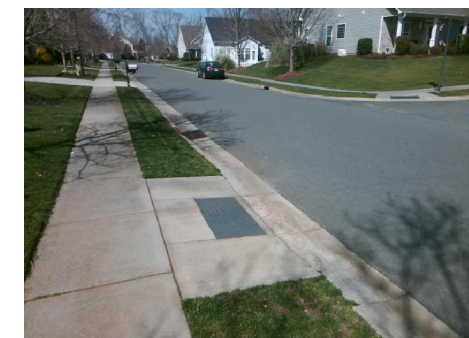
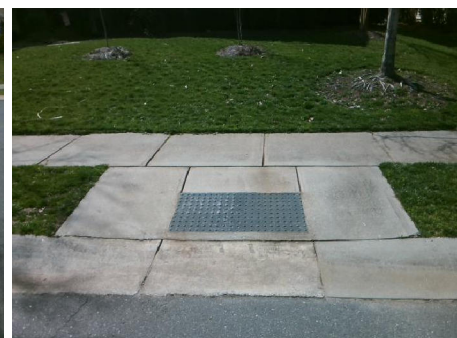
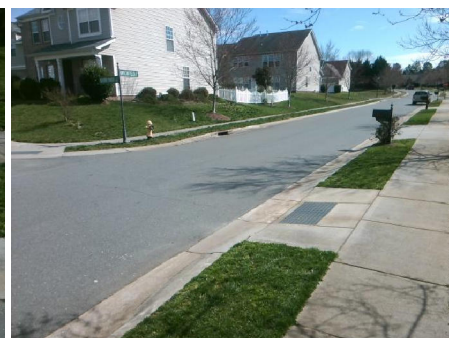
| Compliance | Description | Data | Compliance | Description | Data |
|---|---|---|---|---|---|
| | | | Yes | Surface Condition? (G/P) | Good |
