# Access Compliance Report

## Public Rights-of-Way

### (Curb Ramps)

Intersection ID: 18662	Main Street: GLENHAM_DR	Cross Street: SENECA_PL	Location: SW
ADA ID: 84264B140C01	Ramp Type: PerpDiag	Initial Pass/Fail: Fail	Overall Compliance: No
		Severity Score: 10

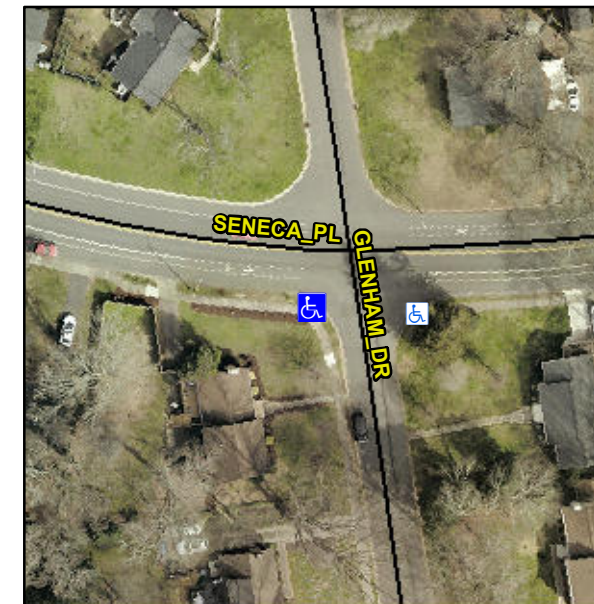
**Not Found, R304.5.1, R304.5.3**

Compliance	Description	Data	Compliance	Description	Data
N/A	Ramp Length (in)	47.0	Yes	Ramp Slope (%)	6.0
No	Ramp Width (in)	47.0	No	Ramp XSlope (%)	2.2
N/A	Flare Type LT	N/A	N/A	Flare Type RT	N/A
N/A	Flare Slope LT (%)	N/A	N/A	Flare Slope RT (%)	N/A
N/A	Flare Traversable LT?	N/A	N/A	Flare Traversable RT?	N/A
N/A	Landing Length (in)	N/A	N/A	DWS Provided?	N/A
N/A	Landing Width (in)	N/A	N/A	DWS Contrast?	N/A
N/A	Landing Slope (%)	N/A	N/A	DWS Length (in)	N/A
N/A	Landing X Slope (%)	N/A	N/A	DWS Full Width?	N/A
N/A	Landing Curb? (Y/N)	N/A	N/A	DWS Offset (in)	N/A
N/A	Shared Landing?	N/A			
N/A	Gutter Ponding?	N/A	N/A	Gutter Slope (%)	N/A
N/A	Gutter Lip Ht (in)	N/A	N/A	Gutter X Slope (%)	N/A
N/A	Painted X Walk1?	No	N/A	Painted X Walk2?	No
	X Walk 1 Direction	To E		X Walk 2 Direction	To N
N/A	X Walk 1 Width (in)	N/A	N/A	X Walk 2 Width (in)	N/A
	X Walk 1 Slope (%)	0.8		X Walk 2 Slope (%)	4.6
	X Walk 1 X Slope (%)	4.7		X Walk 2 X Slope (%)	2.6

N/A	Ramp inside XWalk1?	N/A	N/A	Ramp inside XWalk2?	N/A
	Road Slope (%)	1.5	N/A	Clear Space?	N/A
	Road X Slope (%)	5.8	N/A	Clear Space to XWalk (in)	N/A
N/A	Any Obstructions?	N/A	N/A	Storm Grate/Utility Hazard?	N/A
	Obstruction Type			Storm Grate/Utility Type	
		N/A			N/A
		Yes		Surface Condition? (G/P)	Good

**Remove & Replace Curb Ramp With Two New Directional Ramps or Equivalent.**
