Access Compliance Report

Public Rights-of-Way

(Curb Ramps)

Intersection ID: 43116	Main Street: CENTRAL_AV	Cross Street: PECAN_AV	Location: NE
ADA ID: 843343AC7BF6	Ramp Type: Perp	Initial Pass/Fail: Fail	Overall Compliance: No
Severity Score: 13.75			
Codes/Mitigation Info/Possible Solution		Field Measurements/Component Compliance

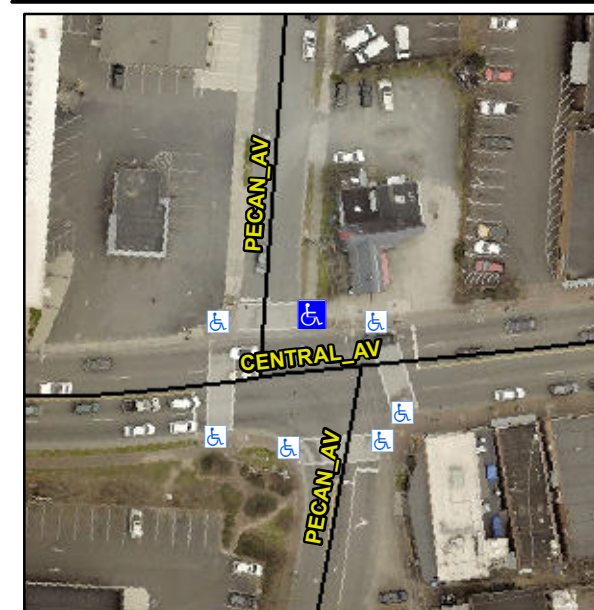
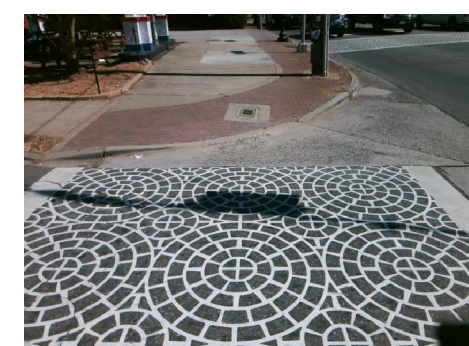
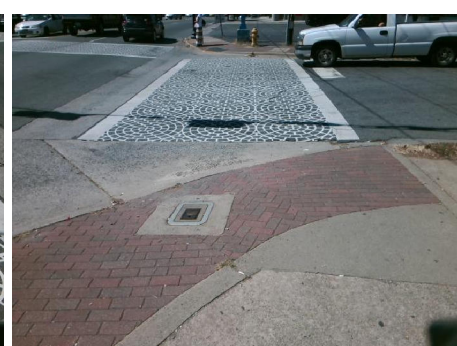
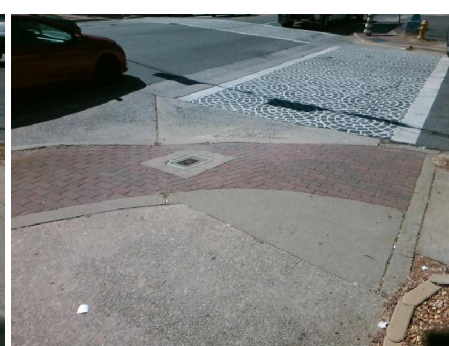
Not Found, R304.2.2, R304.5.3

Compliance	Description	Data	Compliance	Description	Data
N/A	Ramp Length (in)	63.0	No	Ramp Slope (%)	11.5
Yes	Ramp Width (in)	60.0	No	Ramp XSlope (%)	3.9
N/A	Flare Type LT	N/A	N/A	Flare Type RT	N/A
N/A	Flare Slope LT (%)	N/A	N/A	Flare Slope RT (%)	N/A
N/A	Flare Traversable LT?	N/A	N/A	Flare Traversable RT?	N/A
N/A	Landing Length (in)	N/A	N/A	DWS Provided?	N/A
N/A	Landing Width (in)	N/A	N/A	DWS Contrast?	N/A
N/A	Landing Slope (%)	N/A	N/A	DWS Length (in)	N/A
N/A	Landing X Slope (%)	N/A	N/A	DWS Full Width?	N/A
N/A	Landing Curb? (Y/N)	N/A	N/A	DWS Offset (in)	N/A
N/A	Shared Landing?	N/A			
N/A	Gutter Ponding?	N/A	N/A	Gutter Slope (%)	N/A
N/A	Gutter Lip Ht (in)	N/A	N/A	Gutter X Slope (%)	N/A
N/A	Painted X Walk1?	Yes	N/A	Painted X Walk2?	N/A
	X Walk 1 Direction	To W		X Walk 2 Direction	N/A
N/A	X Walk 1 Width (in)	143.0	N/A	X Walk 2 Width (in)	N/A
	X Walk 1 Slope (%)	0.6		X Walk 2 Slope (%)	N/A
	X Walk 1 X Slope (%)	2.5		X Walk 2 X Slope (%)	N/A

N/A	Ramp inside XWalk1?	Yes	N/A	Ramp inside XWalk2?	N/A
	Road Slope (%)	N/A	N/A	Clear Space?	N/A
	Road X Slope (%)	N/A	N/A	Clear Space to XWalk (in)	N/A
N/A	Any Obstructions?	N/A	N/A	Storm Grate/Utility Hazard?	N/A
	Obstruction Type			Storm Grate/Utility Type	
		N/A			N/A
		Yes		Surface Condition? (G/P)	Good

Possible Solutions:

Remove & Replace Entire Ramp.
