Access Compliance Report

Public Rights-of-Way

(Curb Ramps)

Intersection ID: 14512	Main Street: CARONIA_ST	Cross Street: ROSS_AV	Location: SE
ADA ID: 843A1A9AE829	Ramp Type: PerpDiag	Initial Pass/Fail: Fail	Overall Compliance: No
Severity Score: 21.25			
Codes/Mitigation Info/Possible Solution		Field Measurements/Component Compliance

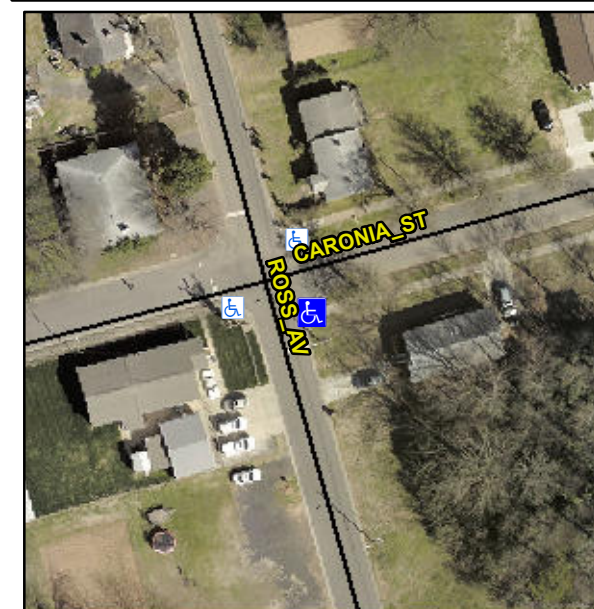
Not Found, R304.5.1, R304.2.2

Compliance	Description	Data	Compliance	Description	Data
N/A	Ramp Length (in)	62.0	No	Ramp Slope (%)	10.6
No	Ramp Width (in)	36.0	Yes	Ramp XSlope (%)	1.5
N/A	Flare Type LT	N/A	N/A	Flare Type RT	N/A
N/A	Flare Slope LT (%)	N/A	N/A	Flare Slope RT (%)	N/A
N/A	Flare Traversable LT?	N/A	N/A	Flare Traversable RT?	N/A
N/A	Landing Length (in)	N/A	N/A	DWS Provided?	N/A
N/A	Landing Width (in)	N/A	N/A	DWS Contrast?	N/A
N/A	Landing Slope (%)	N/A	N/A	DWS Length (in)	N/A
N/A	Landing X Slope (%)	N/A	N/A	DWS Full Width?	N/A
N/A	Landing Curb? (Y/N)	N/A	N/A	DWS Offset (in)	N/A
N/A	Shared Landing?	N/A			
N/A	Gutter Ponding?	N/A	N/A	Gutter Slope (%)	N/A
N/A	Gutter Lip Ht (in)	N/A	N/A	Gutter X Slope (%)	N/A
N/A	Painted X Walk1?	No	N/A	Painted X Walk2?	No
	X Walk 1 Direction	To W		X Walk 2 Direction	To N
N/A	X Walk 1 Width (in)	N/A	N/A	X Walk 2 Width (in)	N/A
	X Walk 1 Slope (%)	1.8		X Walk 2 Slope (%)	1.5
	X Walk 1 X Slope (%)	0.2		X Walk 2 X Slope (%)	1.7

N/A	Ramp inside XWalk1?	N/A	N/A	Ramp inside XWalk2?	N/A
	Road Slope (%)	1.0	N/A	Clear Space?	N/A
	Road X Slope (%)	0.3	N/A	Clear Space to XWalk (in)	N/A
N/A	Any Obstructions?	N/A	N/A	Storm Grate/Utility Hazard?	N/A
	Obstruction Type			Storm Grate/Utility Type	
		N/A			N/A
		Yes		Surface Condition? (G/P)	Good

Possible Solutions:

Remove & Replace Curb Ramp With Two New Directional Ramps or Equivalent.
