# Access Compliance Report

## Public Rights-of-Way

### (Curb Ramps)

Intersection ID: 31701	Main Street: ATLAS_CEDAR_DR	Cross Street: CAROLINA_LAUREL_CT	Location: NW
ADA ID: 843AFA94EBBA	Ramp Type: PerpDiag	Initial Pass/Fail: Fail	Overall Compliance: No
		Severity Score: 10

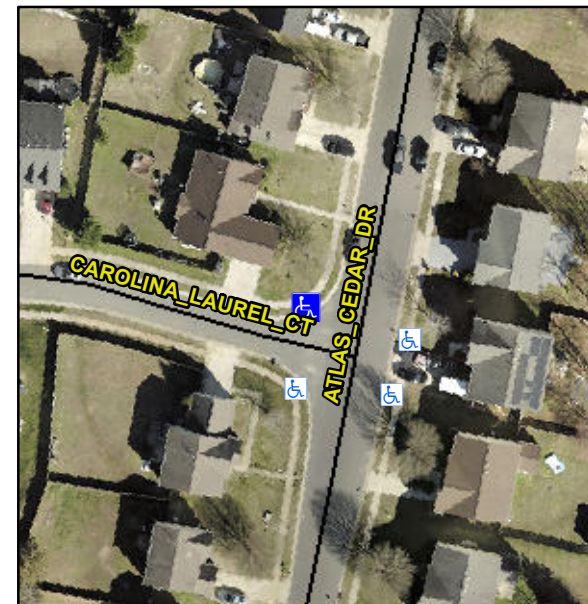
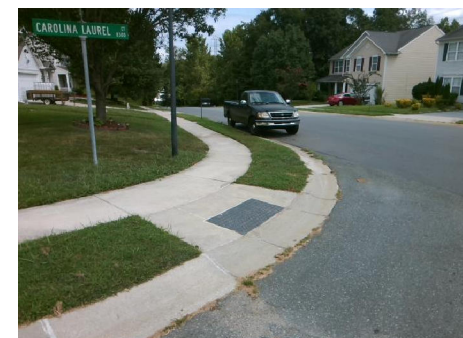
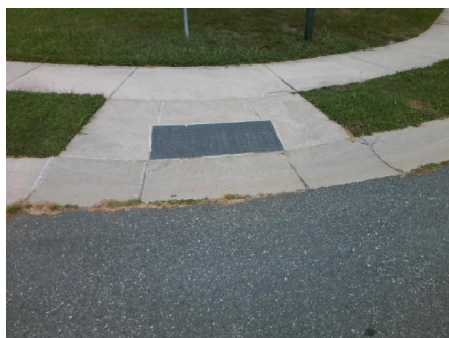
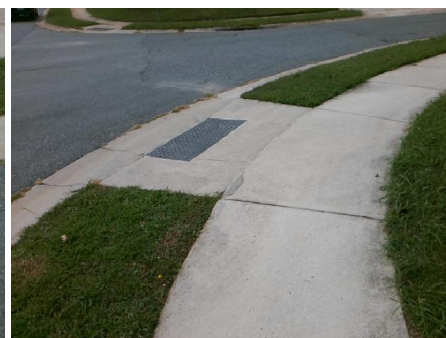
**Not Found, R304.5.1, R304.5.3**

Compliance	Description	Data	Compliance	Description	Data
N/A	Ramp Length (in)	48.0	Yes	Ramp Slope (%)	7.4
No	Ramp Width (in)	38.5	No	Ramp XSlope (%)	4.7
N/A	Flare Type LT	N/A	N/A	Flare Type RT	N/A
N/A	Flare Slope LT (%)	N/A	N/A	Flare Slope RT (%)	N/A
N/A	Flare Traversable LT?	N/A	N/A	Flare Traversable RT?	N/A
N/A	Landing Length (in)	N/A	N/A	DWS Provided?	N/A
N/A	Landing Width (in)	N/A	N/A	DWS Contrast?	N/A
N/A	Landing Slope (%)	N/A	N/A	DWS Length (in)	N/A
N/A	Landing X Slope (%)	N/A	N/A	DWS Full Width?	N/A
N/A	Landing Curb? (Y/N)	N/A	N/A	DWS Offset (in)	N/A
N/A	Shared Landing?	N/A			
N/A	Gutter Ponding?	N/A	N/A	Gutter Slope (%)	N/A
N/A	Gutter Lip Ht (in)	0.5	N/A	Gutter X Slope (%)	N/A
N/A	Painted X Walk1?	No	N/A	Painted X Walk2?	No
	X Walk 1 Direction	To S		X Walk 2 Direction	To E
N/A	X Walk 1 Width (in)	N/A	N/A	X Walk 2 Width (in)	N/A
	X Walk 1 Slope (%)	1.9		X Walk 2 Slope (%)	3.8
	X Walk 1 X Slope (%)	1.2		X Walk 2 X Slope (%)	3.0

N/A	Ramp inside XWalk1?	N/A	N/A	Ramp inside XWalk2?	N/A
	Road Slope (%)	1.4	N/A	Clear Space?	N/A
	Road X Slope (%)	3.6	N/A	Clear Space to XWalk (in)	N/A
N/A	Any Obstructions?	N/A	N/A	Storm Grate/Utility Hazard?	N/A
	Obstruction Type			Storm Grate/Utility Type	
		N/A			N/A
			Yes	Surface Condition? (G/P)	Good

**Remove & Replace Curb Ramp With Two New Directional Ramps or Equivalent.**
