# Access Compliance Report

## Public Rights-of-Way

### (Curb Ramps)

Intersection ID: 6882	Main Street: STATESVILLE_RD	Cross Street: CINDY_LN	Location: NE
ADA ID: 844EF6CD0E11	Ramp Type: Perp	Initial Pass/Fail: Pass	Overall Compliance: No
			Severity Score: 0.25

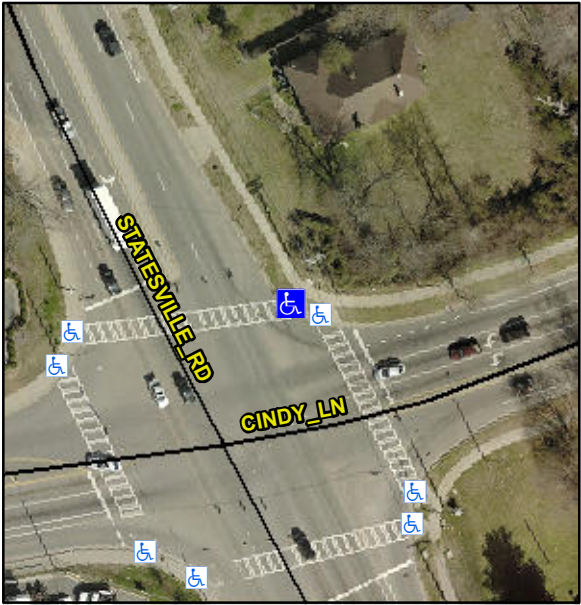
Possible Solutions:		<b>Compliance</b>	<b>Description</b>	<b>Data</b>
	<b>Remove &amp; Replace Entire Ramp.</b>		<b>Yes</b>	Ramp Length (in)	108.5
	<b>Remove &amp; Replace Gutter.</b>		<b>No</b>	Ramp Width (in)	48.0
			<b>N/A</b>	Flare Type LT	Sloped
			<b>N/A</b>	Flare Slope LT (%)	10.6
			<b>N/A</b>	Flare Traversable LT?	No
			<b>Yes</b>	Flare Type RT	N/A
			<b>N/A</b>	Flare Slope RT (%)	5.7
			<b>N/A</b>	Flare Traversable RT?	No
			<b>Yes</b>	Landing Length (in)	59.5
Surveyor Notes:  <b>N/A</b>			<b>Yes</b>	DWS Provided?	Yes
			<b>Yes</b>	Landing Width (in)	49.0
			<b>Yes</b>	DWS Contrast?	Yes
			<b>Yes</b>	DWS Length (in)	24.5
			<b>No</b>	DWS Full Width?	Yes
			<b>No</b>	DWS Offset (in)	1.0
			<b>N/A</b>	Landing X Slope (%)	2.6
			<b>N/A</b>	Landing Curb? (Y/N)	No
			<b>N/A</b>	Shared Landing?	No
			<b>No</b>	Gutter Ponding?	Yes

PROW/ADA:  <b>Not Found, R304.5.3, R302.7</b>			<b>Yes</b>	Gutter Slope (%)	4.0
			<b>No</b>	Gutter Lip Ht (in)	0.0
			<b>Yes</b>	Gutter X Slope (%)	2.7
			<b>N/A</b>	Painted X Walk1?	N/A
			<b>Yes</b>	Painted X Walk2?	N/A
			<b>To W</b>	X Walk 1 Direction	N/A
			<b>N/A</b>	X Walk 2 Direction	N/A
			<b>N/A</b>	X Walk 1 Width (in)	N/A
			<b>N/A</b>	X Walk 2 Width (in)	N/A
			<b>N/A</b>	X Walk 1 Slope (%)	N/A
Total Cost:			<b>N/A</b>	X Walk 2 Slope (%)	N/A
			<b>N/A</b>	X Walk 1 X Slope (%)	N/A
			<b>Yes</b>	X Walk 2 X Slope (%)	N/A
			<b>Yes</b>	Ramp inside XWalk1?	N/A
			<b>N/A</b>	Ramp inside XWalk2?	N/A
			<b>N/A</b>	Road Slope (%)	Yes
			<b>N/A</b>	Road X Slope (%)	N/A
			<b>N/A</b>	Clear Space?	N/A
			<b>N/A</b>	Clear Space to XWalk (in)	N/A
			<b>Yes</b>	Any Obstructions?	No
\$ 2600.00			<b>No</b>	Storm Grate/Utility Hazard?	No
				Obstruction Type	
			<b>N/A</b>	Storm Grate/Utility Type	
			<b>N/A</b>		N/A

<b>Yes</b>	Surface Condition? (G/P)	Good
