Access Compliance Report

Public Rights-of-Way

(Curb Ramps)

| Intersection ID: 11877 | Main Street: BILLY_GRAHAM_PY | Cross Street: N/A | Location: NW |

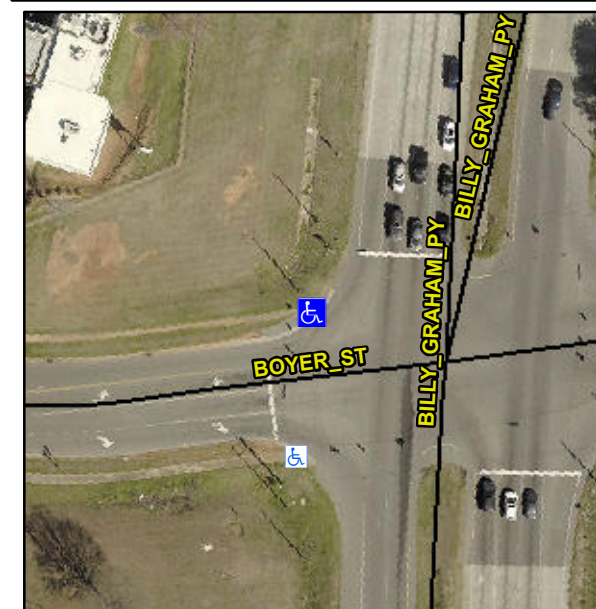
| ADA ID: 844F4FFB2219 | Ramp Type: Perp | Initial Pass/Fail: Fail | Overall Compliance: No |
| Severity Score: 36.25 | | | |

Not Found, R304.5.1, R304.2.2, R302.7

| Compliance | Description | Data | Compliance | Description | Data |
|---|---|---|---|---|---|
| N/A | Ramp Length (in) | 60.0 | No | Ramp Slope (%) | 10.1 |
| No | Ramp Width (in) | 46.0 | Yes | Ramp XSlope (%) | 0.9 |
| | | No | | Surface Condition? (G/P) | Poor |

Possible Solutions:

Remove & Replace Entire Ramp.

Total Cost: \$ 1850.00
