Access Compliance Report

Public Rights-of-Way

(Curb Ramps)

Intersection ID: 16008	Main Street: SEDGEFIELD_RD	Cross Street: WRISTON_PL	Location: NE
ADA ID: 845255C64A30	Ramp Type: Directional1	Initial Pass/Fail: Fail	Overall Compliance: No
		Severity Score: 12.5

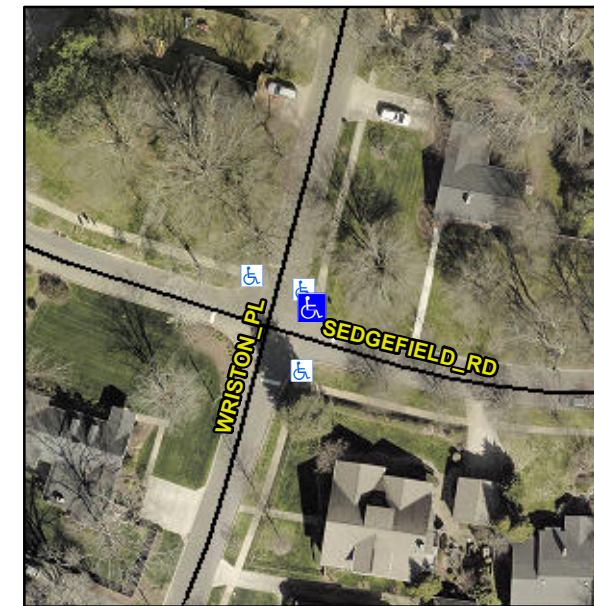
Compliance	Description	Data	Compliance	Description	Data
N/A	Ramp Length (in)	76.0	N/A	Grade Break?	N/A
Yes	Ramp Width (in)	49.0	N/A	Grade Break Slope (%)	0.0
No	Ramp Slope (%)	10.7	N/A	Grade Break XSlope (%)	0.0
Yes	Ramp XSlope (%)	1.0			
N/A	Flare Type LT	N/A	N/A	Flare Type RT	N/A
N/A	Flare Slope LT (%)	N/A	N/A	Flare Slope RT (%)	0.0
N/A	Flare Traversable LT?	N/A	N/A	Flare Traversable RT?	N/A
N/A	Landing Length (in)	0.0	N/A	DWS Provided?	N/A
N/A	Landing Width (in)	0.0	N/A	DWS Contrast?	N/A
N/A	Landing Slope (%)	0.0	N/A	DWS Length (in)	N/A
N/A	Landing X Slope (%)	0.0	N/A	DWS Full Width?	N/A
N/A	Landing Curb? (Y/N)	N/A	N/A	DWS Offset LT (in)	N/A
N/A	Shared Landing?	N/A	N/A	DWS Offset RT (in)	N/A
N/A	Gutter Ponding?	0.0	N/A	Gutter Slope (%)	N/A
N/A	Gutter Lip Ht (in)	0.0	N/A	Gutter X Slope (%)	N/A
N/A	Painted X Walk1?	No		Road Slope (%)	0.5
	X Walk 1 Direction	To S		Road X Slope (%)	0.7
	X Walk 1 Width (in)	N/A		Clear Space?	N/A

X Walk 1 Slope (%)	0.5	N/A	Clear Space to XWalk (in)	N/A
	X Walk 1 X Slope (%)	0.7	N/A	Storm Grate/Utility Hazard?	N/A
N/A	Ramp inside XWalk1?	N/A		Storm Grate/Utility Type	
N/A	Any Obstructions?	N/A			N/A
	Obstruction Type		Yes	Surface Condition? (G/P)	Good
			N/A	Curb Slope (%)	0.7

Remove & Replace Entire Ramp.

Total Cost: \$ 1600.00
