Access Compliance Report

Public Rights-of-Way

(Curb Ramps)

Intersection ID: N/A	Main Street: SOUTH_STREAM_BV	Cross Street: N/A	Location: SW
ADA ID: 84530CE0197D	Ramp Type: PerpDiag	Initial Pass/Fail: Fail	Overall Compliance: No
Codes/Mitigation Info/Possible Solution		Field Measurements/Component Compliance

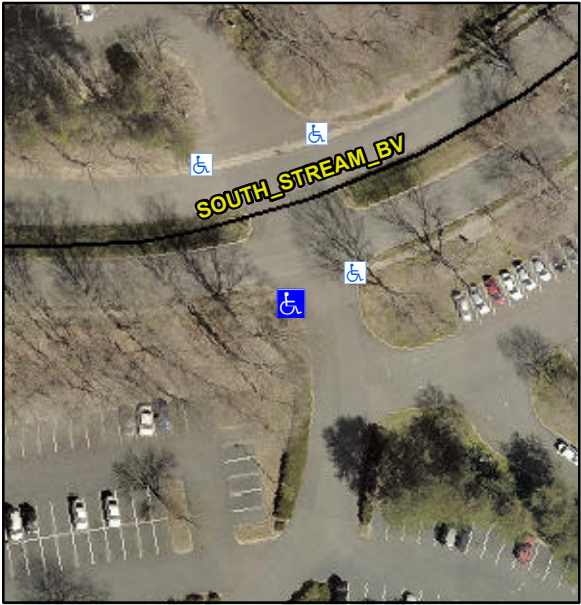
Possible Solutions:	Compliance	Description	Data	Compliance	Description	Data
	Remove & Replace Curb Ramp With Two New Directional Ramps or Equivalent.	N/A	Ramp Length (in)	60.0	No	Ramp Slope (%)	14.8
<p>Surveyor Notes:</p> <p>N/A</p> <p>PROW/ADA:</p> <p>Not Found, R304.5.1, R304.2.2, R304.5.3</p>		No	Ramp Width (in)	45.0	No	Ramp XSlope (%)	5.3
		N/A	Flare Type LT	N/A	N/A	Flare Type RT	N/A
		N/A	Flare Slope LT (%)	N/A	N/A	Flare Slope RT (%)	N/A
		N/A	Flare Traversable LT?	No	N/A	Flare Traversable RT?	No
		N/A	Landing Length (in)	N/A	N/A	DWS Provided?	N/A
		N/A	Landing Width (in)	N/A	N/A	DWS Contrast?	N/A
		N/A	Landing Slope (%)	N/A	N/A	DWS Length (in)	N/A
		N/A	Landing X Slope (%)	N/A	N/A	DWS Full Width?	N/A
		N/A	Landing Curb? (Y/N)	N/A	N/A	DWS Offset (in)	N/A
		N/A	Shared Landing?	N/A			
		N/A	Gutter Ponding?	N/A	N/A	Gutter Slope (%)	N/A
		N/A	Gutter Lip Ht (in)	N/A	N/A	Gutter X Slope (%)	N/A
		N/A	Painted X Walk1?	No	N/A	Painted X Walk2?	No

X Walk 1 Direction	To E		X Walk 2 Direction	To N
		N/A	X Walk 1 Width (in)	N/A	N/A	X Walk 2 Width (in)	N/A
			X Walk 1 Slope (%)	4.0		X Walk 2 Slope (%)	5.6
			X Walk 1 X Slope (%)	6.1		X Walk 2 X Slope (%)	6.9
		N/A	Ramp inside XWalk1?	N/A	N/A	Ramp inside XWalk2?	N/A
			Road Slope (%)	5.5	N/A	Clear Space?	N/A
			Road X Slope (%)	0.1	N/A	Clear Space to XWalk (in)	N/A
		N/A	Any Obstructions?	N/A	N/A	Storm Grate/Utility Hazard?	N/A
			Obstruction Type			Storm Grate/Utility Type	
				N/A			N/A
					Yes	Surface Condition? (G/P)	Good

Total Cost: \$ 3200.00
