Access Compliance Report

Public Rights-of-Way

(Curb Ramps)

Intersection ID: 9616	Main Street: BRIARWOOD_DR	Cross Street: THE_PLAZA	Location: SW
ADA ID: 8456D04230F3	Ramp Type: Perp	Initial Pass/Fail: Fail	Overall Compliance: No
Codes/Mitigation Info/Possible Solution		Field Measurements/Component Compliance

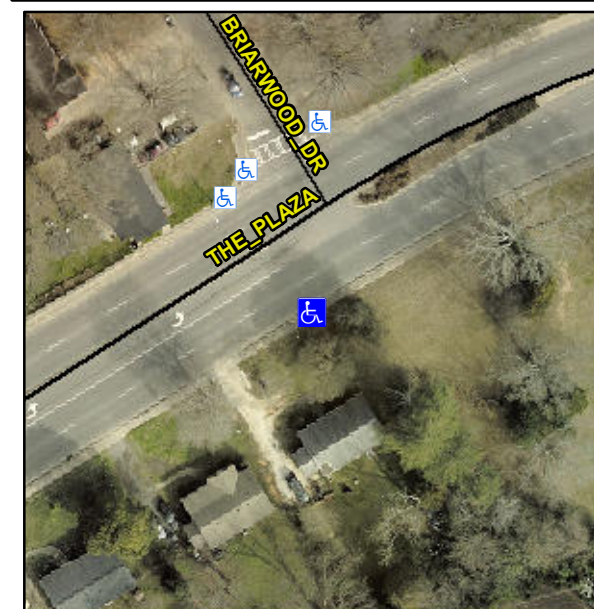
Not Found, R304.2.2, R304.5.3

Compliance	Description	Data	Compliance	Description	Data
N/A	Ramp Length (in)	56.5	No	Ramp Slope (%)	9.0
Yes	Ramp Width (in)	48.0	No	Ramp XSlope (%)	3.4
N/A	Flare Type LT	N/A	N/A	Flare Type RT	N/A
N/A	Flare Slope LT (%)	N/A	N/A	Flare Slope RT (%)	N/A
N/A	Flare Traversable LT?	N/A	N/A	Flare Traversable RT?	N/A
N/A	Landing Length (in)	N/A	N/A	DWS Provided?	N/A
N/A	Landing Width (in)	N/A	N/A	DWS Contrast?	N/A
N/A	Landing Slope (%)	N/A	N/A	DWS Length (in)	N/A
N/A	Landing X Slope (%)	N/A	N/A	DWS Full Width?	N/A
N/A	Landing Curb? (Y/N)	N/A	N/A	DWS Offset (in)	N/A
N/A	Shared Landing?	N/A			
N/A	Gutter Ponding?	N/A	N/A	Gutter Slope (%)	N/A
N/A	Gutter Lip Ht (in)	N/A	N/A	Gutter X Slope (%)	N/A
N/A	Painted X Walk1?	No	N/A	Painted X Walk2?	N/A
	X Walk 1 Direction	To NW		X Walk 2 Direction	N/A
N/A	X Walk 1 Width (in)	N/A	N/A	X Walk 2 Width (in)	N/A
	X Walk 1 Slope (%)	1.9		X Walk 2 Slope (%)	N/A
	X Walk 1 X Slope (%)	1.7		X Walk 2 X Slope (%)	N/A

N/A	Ramp inside XWalk1?	N/A	N/A	Ramp inside XWalk2?	N/A
	Road Slope (%)	N/A	N/A	Clear Space?	N/A
	Road X Slope (%)	N/A	N/A	Clear Space to XWalk (in)	N/A
N/A	Any Obstructions?	N/A	N/A	Storm Grate/Utility Hazard?	N/A
	Obstruction Type			Storm Grate/Utility Type	
		N/A			N/A
			Yes	Surface Condition? (G/P)	Good

Possible Solutions:

Remove & Replace Entire Ramp.
