Access Compliance Report

Public Rights-of-Way

(Curb Ramps)

Intersection ID: 29992	Main Street: REIGATE_RD	Cross Street: KEMPSFORD_DR	Location:	N
ADA ID: 8456F8A9E6D9	Ramp Type: PerpDiag	Initial Pass/Fail: Fail	Overall Compliance: No	Severity Score: 22.5
Codes/Mitigation Info/Possible Solution		Field Measurements/Component Compliance

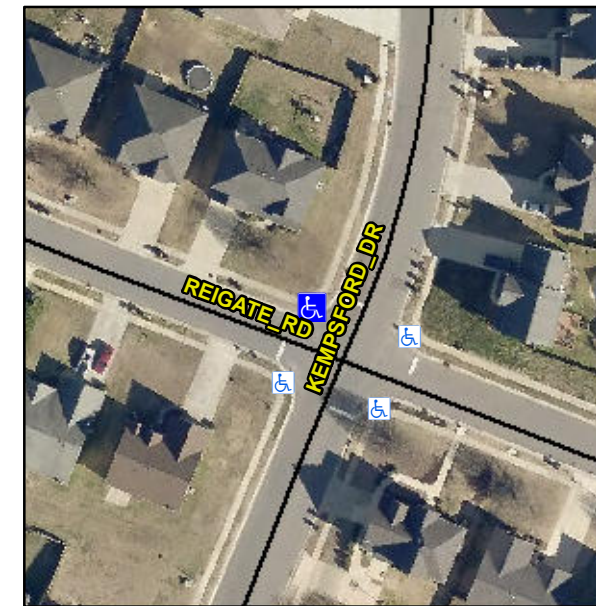
Not Found, R304.5.1, R304.2.2, R304.5.3

Compliance	Description	Data	Compliance	Description	Data
N/A	Ramp Length (in)	47.5	No	Ramp Slope (%)	8.4
No	Ramp Width (in)	41.0	No	Ramp XSlope (%)	4.8
N/A	Flare Type LT	N/A	N/A	Flare Type RT	N/A
N/A	Flare Slope LT (%)	N/A	N/A	Flare Slope RT (%)	N/A
N/A	Flare Traversable LT?	N/A	N/A	Flare Traversable RT?	N/A
N/A	Landing Length (in)	N/A	N/A	DWS Provided?	N/A
N/A	Landing Width (in)	N/A	N/A	DWS Contrast?	N/A
N/A	Landing Slope (%)	N/A	N/A	DWS Length (in)	N/A
N/A	Landing X Slope (%)	N/A	N/A	DWS Full Width?	N/A
N/A	Landing Curb? (Y/N)	N/A	N/A	DWS Offset (in)	N/A
N/A	Shared Landing?	N/A			
N/A	Gutter Ponding?	N/A	N/A	Gutter Slope (%)	N/A
N/A	Gutter Lip Ht (in)	N/A	N/A	Gutter X Slope (%)	N/A
N/A	Painted X Walk1?	No	N/A	Painted X Walk2?	No
	X Walk 1 Direction	To SE		X Walk 2 Direction	To SW
N/A	X Walk 1 Width (in)	N/A	N/A	X Walk 2 Width (in)	N/A
	X Walk 1 Slope (%)	3.3		X Walk 2 Slope (%)	3.9
	X Walk 1 X Slope (%)	3.9		X Walk 2 X Slope (%)	1.1

N/A	Ramp inside XWalk1?	N/A	N/A	Ramp inside XWalk2?	N/A
	Road Slope (%)	0.3	N/A	Clear Space?	N/A
	Road X Slope (%)	3.3	N/A	Clear Space to XWalk (in)	N/A
N/A	Any Obstructions?	N/A	N/A	Storm Grate/Utility Hazard?	N/A
	Obstruction Type			Storm Grate/Utility Type	
		N/A			N/A
			Yes	Surface Condition? (G/P)	Good

Possible Solutions:

Remove & Replace Curb Ramp With Two New Directional Ramps or Equivalent.
