Access Compliance Report Public Rights-of-Way (Curb Ramps)

Intersection ID: 29677 Main Street: CAMERON_CREEK_DR Cross Street: HUNTINGTON_RIDGE_CT Location: SW

ADA ID: 845C204A2384 Ramp Type: PerpDiag Initial Pass/Fail: Fail Overall Compliance: No Severity Score: 12.5

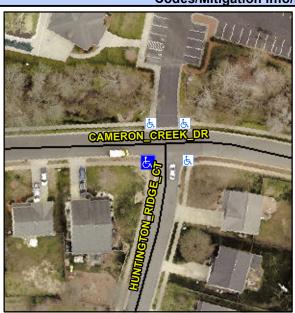
Field Measurements/Component Compliance							
Compliance Description		Data	Comp	liance Description	Data		
N/A	Ramp Length (in)	45.0	No	Ramp Slope (%)	8.5		
Yes	Ramp Width (in)	48.0	Yes	Ramp XSlope (%)	0.6		
N/A	Flare Type LT	N/A	N/A	Flare Type RT	N/A		
N/A	Flare Slope LT (%)	N/A	N/A	Flare Slope RT (%)	N/A		
N/A	Flare Traversable LT?	N/A	N/A	Flare Traversable RT?	N/A		
N/A	Landing Length (in)	N/A	N/A	DWS Provided?	N/A		
N/A	Landing Width (in)	N/A	N/A	DWS Contrast?	N/A		
N/A	Landing Slope (%)	N/A	N/A	DWS Length (in)	N/A		
N/A	Landing X Slope (%)	N/A	N/A	DWS Full Width?	N/A		
N/A	Landing Curb? (Y/N)	N/A	N/A	DWS Offset (in)	N/A		
N/A	Shared Landing?	N/A					
N/A	Gutter Ponding?	N/A	N/A	Gutter Slope (%)	N/A		
N/A	Gutter Lip Ht (in)	N/A	N/A	Gutter X Slope (%)	N/A		
N/A	Painted X Walk1?	No	N/A	Painted X Walk2?	No		
	X Walk 1 Direction	To E		X Walk 2 Direction	To N		
N/A	X Walk 1 Width (in)	N/A	N/A	X Walk 2 Width (in)	N/A

X Walk 1 Slope (%)	0.5		X Walk 2 Slope (%)	4.2		
	X Walk 1 X Slope (%)	0.1		X Walk 2 X Slope (%)	1.1		
N/A	Ramp inside XWalk1?	N/A	N/A	Ramp inside XWalk2?	N/A		
	Road Slope (%)	1.9	N/A	Clear Space?	N/A		
	Road X Slope (%)	0.9	N/A	Clear Space to XWalk (in)	N/A		
N/A	Any Obstructions?	N/A	N/A	Storm Grate/Utility Hazard?	N/A		
	Obstruction Type			Storm Grate/Utility Type			
		N/A			N/A		
			Yes	Surface Condition? (G/P)	Good

Possible Solutions:	<u>C</u>			
Remove & Replace Curb Ramp With				
Two New Directional Ramps or	Ye			
Equivalent.	N/			
	N/			
	N/			
	N/			
Surveyor Notes:	N/			
N/A	N/			
	N/			
	N/			
	N/			
PROW/ADA:	N/			
Not Found, R304.2.2	N/			
	N/			
	N/			
	N/
