## Access Compliance Report Public Rights-of-Way (Curb Ramps)

Intersection ID: 27582 Main Street: BALLANTYNE\_COUNTRY\_CLUBrooms Street: LEDERER\_AV Location: NW

ADA ID: 84605EDDDA53 Ramp Type: BlendTrans2 Initial Pass/Fail: Fail Overall Compliance: No Severity Score: 12.5

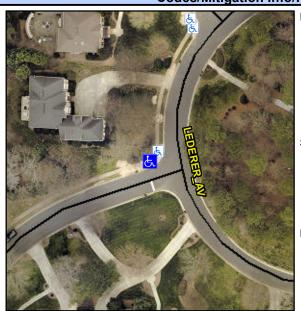
PROW/ADA:
Not Found, R304.5.3

Compliance Description Data Compliance Description Data Yes BlendTrans Slope (%) N/A Ramp Length (in) 99.0 0.0 No Yes Ramp Width (in) 48.0 BlendTrans XSlope (%) 6.3 N/A N/A Flare Type LT N/A Flare Type RT N/A N/A Flare Slope LT (%) N/A N/A Flare Slope RT (%) N/A N/A Flare Traversable LT? N/A N/A Flare Traversable RT? N/A N/A N/A N/A **DWS Provided?** N/A Landing Length (in) N/A Landing Width (in) N/A N/A **DWS Contrast?** N/A N/A N/A N/A Landing Slope (%) DWS Length (in) N/A N/A Landing X Slope (%) N/A N/A DWS Full Width? N/A N/A Landing Curb? (Y/N) N/A N/A DWS Offset (in) N/A N/A N/A Shared Landing? N/A **Gutter Ponding?** N/A N/A Gutter Slope (%) N/A N/A Gutter Lip Ht (in) N/A N/A Gutter X Slope (%) N/A N/A Painted X Walk1? No N/A Painted X Walk2? N/A X Walk 1 Direction To SE X Walk 2 Direction N/A N/A X Walk 1 Width (in) X Walk 2 Width (in) N/A X Walk 1 Slope (%) 4.0 X Walk 2 Slope (%) N/A X Walk 1 X Slope (%) 4.2 X Walk 2 X Slope (%) N/A N/A N/A Ramp inside XWalk2? N/A Ramp inside XWalk1? N/A Road Slope (%) 4.2 Clear Space? N/A N/A Road X Slope (%) Clear Space to XWalk (in) N/A 4.0 N/A N/A N/A Any Obstructions? Storm Grate/Utility Hazard? N/A Obstruction Type Storm Grate/Utility Type N/A N/A

Remove & Replace Curb Ramp With
Two New Directional Ramps or
Equivalent.

Total Cost: \$ 3200.00
