Access Compliance Report

Public Rights-of-Way

(Curb Ramps)

Intersection ID: 21519	Main Street: AMYINGTON_DR	Cross Street: COLONY_RD	Location:	N
ADA ID: 84653B1527DF	Ramp Type: Perp	Initial Pass/Fail: Fail	Overall Compliance: No	Severity Score: 21.25
Codes/Mitigation Info/Possible Solution		Field Measurements/Component Compliance

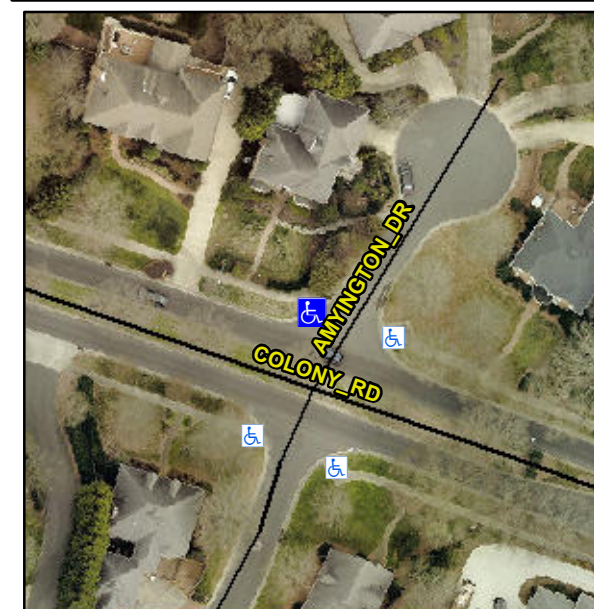
Not Found, R304.5.1, R304.5.3

Compliance	Description	Data	Compliance	Description	Data
N/A	Ramp Length (in)	104.0	Yes	Ramp Slope (%)	5.2
No	Ramp Width (in)	36.0	No	Ramp XSlope (%)	5.8
N/A	Flare Type LT	N/A	N/A	Flare Type RT	N/A
N/A	Flare Slope LT (%)	N/A	N/A	Flare Slope RT (%)	N/A
N/A	Flare Traversable LT?	N/A	N/A	Flare Traversable RT?	N/A
N/A	Landing Length (in)	N/A	N/A	DWS Provided?	N/A
N/A	Landing Width (in)	N/A	N/A	DWS Contrast?	N/A
N/A	Landing Slope (%)	N/A	N/A	DWS Length (in)	N/A
N/A	Landing X Slope (%)	N/A	N/A	DWS Full Width?	N/A
N/A	Landing Curb? (Y/N)	N/A	N/A	DWS Offset (in)	N/A
N/A	Shared Landing?	N/A			
N/A	Gutter Ponding?	N/A	N/A	Gutter Slope (%)	N/A
N/A	Gutter Lip Ht (in)	N/A	N/A	Gutter X Slope (%)	N/A
N/A	Painted X Walk1?	No	N/A	Painted X Walk2?	N/A
	X Walk 1 Direction	To SE		X Walk 2 Direction	N/A
N/A	X Walk 1 Width (in)	N/A	N/A	X Walk 2 Width (in)	N/A
	X Walk 1 Slope (%)	5.6		X Walk 2 Slope (%)	N/A
	X Walk 1 X Slope (%)	1.4		X Walk 2 X Slope (%)	N/A

N/A	Ramp inside XWalk1?	N/A	N/A	Ramp inside XWalk2?	N/A
	Road Slope (%)	N/A	N/A	Clear Space?	N/A
	Road X Slope (%)	N/A	N/A	Clear Space to XWalk (in)	N/A
N/A	Any Obstructions?	N/A	N/A	Storm Grate/Utility Hazard?	N/A
	Obstruction Type			Storm Grate/Utility Type	
		N/A			N/A
			Yes	Surface Condition? (G/P)	Good

Remove & Replace Entire Ramp.

Total Cost: \$ 1850.00
