# Access Compliance Report

## Public Rights-of-Way

### (Curb Ramps)

Intersection ID: 53893	Main Street: PERTH_MOOR_RD	Cross Street: HAMILTON_BRIDGE_RD	Location: NE
ADA ID: 8467DBEB5183	Ramp Type: BlendTrans1	Initial Pass/Fail: Fail	Overall Compliance: No
Codes/Mitigation Info/Possible Solution		Field Measurements/Component Compliance	
Severity Score: 8.75

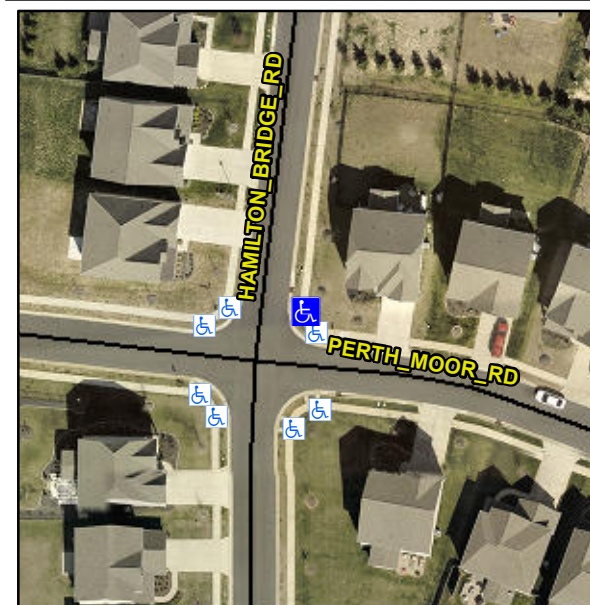
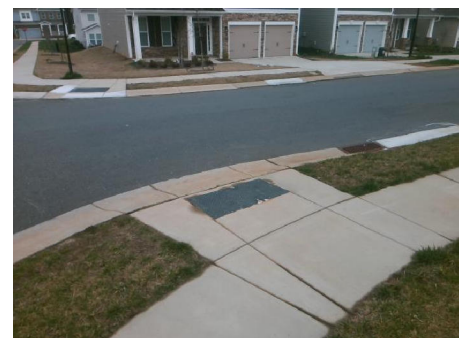
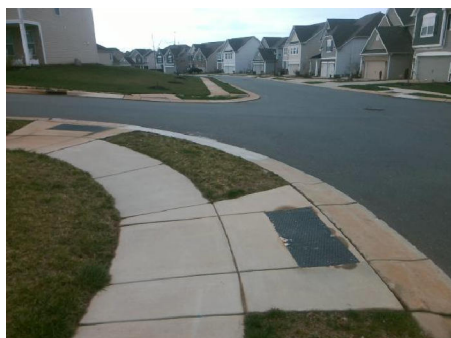
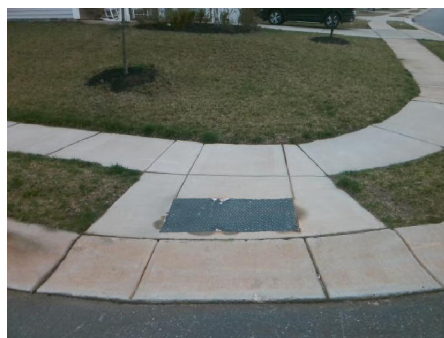
**Not Found, R304.5.1**

Compliance	Description	Data	Compliance	Description	Data
N/A	Ramp Length (in)	49.0	Yes	BlendTrans Slope (%)	1.0
No	Ramp Width (in)	45.5	Yes	BlendTrans XSlope (%)	1.3
N/A	Flare Type LT	N/A	N/A	Flare Type RT	N/A
N/A	Flare Slope LT (%)	N/A	N/A	Flare Slope RT (%)	N/A
N/A	Flare Traversable LT?	N/A	N/A	Flare Traversable RT?	N/A
N/A	Landing Length (in)	N/A	N/A	DWS Provided?	N/A
N/A	Landing Width (in)	N/A	N/A	DWS Contrast?	N/A
N/A	Landing Slope (%)	N/A	N/A	DWS Length (in)	N/A
N/A	Landing X Slope (%)	N/A	N/A	DWS Full Width?	N/A
N/A	Landing Curb? (Y/N)	N/A	N/A	DWS Offset (in)	N/A
N/A	Shared Landing?	N/A			
N/A	Gutter Ponding?	N/A	N/A	Gutter Slope (%)	N/A
N/A	Gutter Lip Ht (in)	1.0	N/A	Gutter X Slope (%)	N/A
N/A	Painted X Walk1?	No	N/A	Painted X Walk2?	N/A
	X Walk 1 Direction	To W		X Walk 2 Direction	N/A
	X Walk 1 Width (in)	N/A		X Walk 2 Width (in)	N/A
	X Walk 1 Slope (%)	0.0		X Walk 2 Slope (%)	N/A
	X Walk 1 X Slope (%)	3.1		X Walk 2 X Slope (%)	N/A

N/A	Ramp inside XWalk1?	N/A	N/A	Ramp inside XWalk2?	N/A
	Road Slope (%)	3.1		Clear Space?	N/A
	Road X Slope (%)	0.0	N/A	Clear Space to XWalk (in)	N/A
N/A	Any Obstructions?	N/A	N/A	Storm Grate/Utility Hazard?	N/A
	Obstruction Type			Storm Grate/Utility Type	
		N/A			N/A
			Yes	Surface Condition? (G/P)	Good
			No	Curb Slope (%)	14.2

**Remove & Replace Curb Ramp With Two New Directional Ramps or Equivalent.**
