Access Compliance Report

Public Rights-of-Way

(Curb Ramps)

Intersection ID: 50938	Main Street: BLAIREBETH_ST	Cross Street: CANMORE_ST	Location: SW
ADA ID: 8480CE231A02	Ramp Type: BlendTrans1	Initial Pass/Fail: Fail	Overall Compliance: No
		Severity Score: 12.5

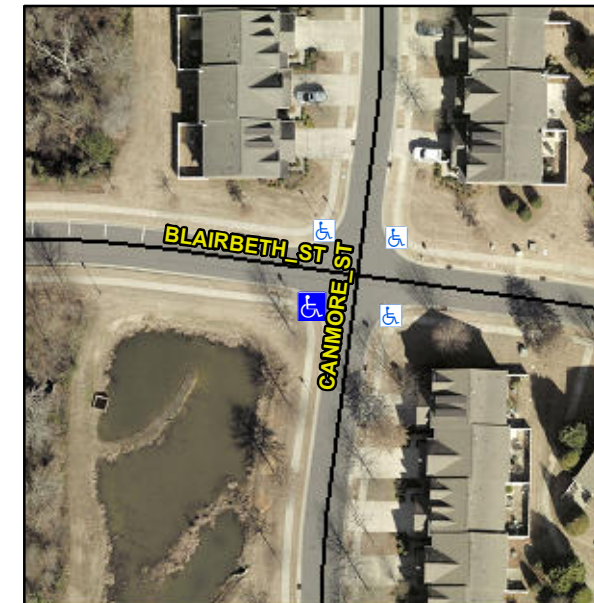
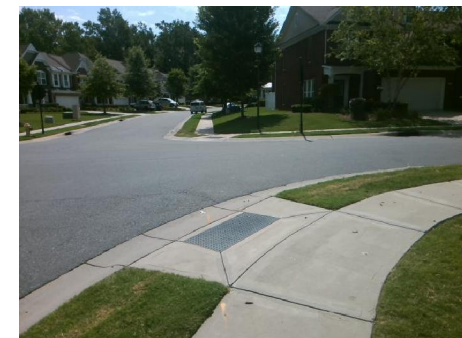
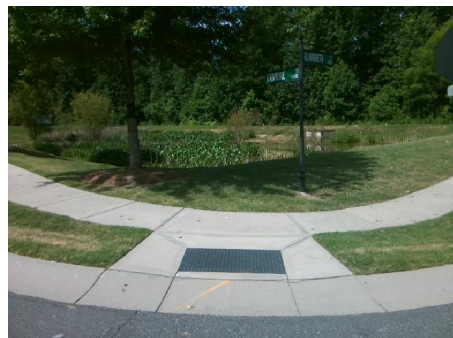
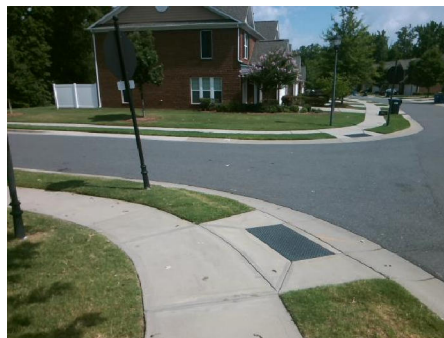
Not Found, R304.5.3

Compliance	Description	Data	Compliance	Description	Data
N/A	Ramp Length (in)	48.0	Yes	BlendTrans Slope (%)	4.6
Yes	Ramp Width (in)	48.0	No	BlendTrans XSlope (%)	6.0
N/A	Flare Type LT	N/A	N/A	Flare Type RT	N/A
N/A	Flare Slope LT (%)	N/A	N/A	Flare Slope RT (%)	N/A
N/A	Flare Traversable LT?	N/A	N/A	Flare Traversable RT?	N/A
N/A	Landing Length (in)	N/A	N/A	DWS Provided?	N/A
N/A	Landing Width (in)	N/A	N/A	DWS Contrast?	N/A
N/A	Landing Slope (%)	N/A	N/A	DWS Length (in)	N/A
N/A	Landing X Slope (%)	N/A	N/A	DWS Full Width?	N/A
N/A	Landing Curb? (Y/N)	N/A	N/A	DWS Offset (in)	N/A
N/A	Shared Landing?	N/A			
N/A	Gutter Ponding?	N/A	N/A	Gutter Slope (%)	N/A
N/A	Gutter Lip Ht (in)	N/A	N/A	Gutter X Slope (%)	N/A
N/A	Painted X Walk1?	No	N/A	Painted X Walk2?	No
	X Walk 1 Direction	To E		X Walk 2 Direction	To N
	X Walk 1 Width (in)	N/A		X Walk 2 Width (in)	N/A
	X Walk 1 Slope (%)	3.2		X Walk 2 Slope (%)	1.7
	X Walk 1 X Slope (%)	2.6		X Walk 2 X Slope (%)	2.7

N/A	Ramp inside XWalk1?	N/A	N/A	Ramp inside XWalk2?	N/A
	Road Slope (%)	3.6		Clear Space?	N/A
	Road X Slope (%)	0.1	N/A	Clear Space to XWalk (in)	N/A
N/A	Any Obstructions?	N/A	N/A	Storm Grate/Utility Hazard?	N/A
	Obstruction Type			Storm Grate/Utility Type	
		N/A			N/A
			Yes	Surface Condition? (G/P)	Good
			No	Curb Slope (%)	9.6

Remove & Replace Curb Ramp With Two New Directional Ramps or Equivalent.
