Access Compliance Report Public Rights-of-Way (Curb Ramps)

Intersection ID: 7621 Main Street: N_I-85_EXIT_39_RA Cross Street: STATESVILLE_AV Location: E

ADA ID: 8481BB14CCC7 Ramp Type: Perp Initial Pass/Fail: Fail Overall Compliance: No Severity Score: 12.5

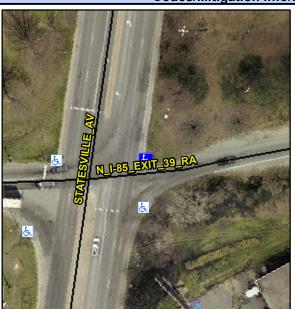
Field Measurements/Component Compliance							
Comp	Compliance Description		Compliance Description		Data		
N/A	Ramp Length (in)	60.0	No	Ramp Slope (%)	11.7		
Yes	Ramp Width (in)	60.0	Yes	Ramp XSlope (%)	1.5		
N/A	Flare Type LT	N/A	N/A	Flare Type RT	N/A		
N/A	Flare Slope LT (%)	N/A	N/A	Flare Slope RT (%)	N/A		
N/A	Flare Traversable LT?	N/A	N/A	Flare Traversable RT?	N/A		
N/A	Landing Length (in)	N/A	N/A	DWS Provided?	N/A		
N/A	Landing Width (in)	N/A	N/A	DWS Contrast?	N/A		
N/A	Landing Slope (%)	N/A	N/A	DWS Length (in)	N/A		
N/A	Landing X Slope (%)	N/A	N/A	DWS Full Width?	N/A		
N/A	Landing Curb? (Y/N)	N/A	N/A	DWS Offset (in)	N/A		
N/A	Shared Landing?	N/A					
N/A	Gutter Ponding?	N/A	N/A	Gutter Slope (%)	N/A		
N/A	Gutter Lip Ht (in)	N/A	N/A	Gutter X Slope (%)	N/A		
N/A	Painted X Walk1?	No	N/A	Painted X Walk2?	N/A		
	X Walk 1 Direction	To S		X Walk 2 Direction	N/A		
N/A	X Walk 1 Width (in)	N/A	N/A	X Walk 2 Width (in)	N/A

X Walk 1 Slope (%)	3.9		X Walk 2 Slope (%)	N/A		
	X Walk 1 X Slope (%)	1.7		X Walk 2 X Slope (%)	N/A		
N/A	Ramp inside XWalk1?	N/A	N/A	Ramp inside XWalk2?	N/A		
	Road Slope (%)	N/A	N/A	Clear Space?	N/A		
	Road X Slope (%)	N/A	N/A	Clear Space to XWalk (in)	N/A		
N/A	Any Obstructions?	N/A	N/A	Storm Grate/Utility Hazard?	N/A		
	Obstruction Type			Storm Grate/Utility Type			
		N/A			N/A		
			Yes	Surface Condition? (G/P)	Good

4		
No.	Possible Solutions:	Com
	Remove & Replace Entire Ramp.	N/A
		Yes
		N/A
	Surveyor Notes:	N/A
	N/A	N/A
i de		N/A
		N/A
		N/A
	PROW/ADA:	N/A
	Not Found, R304.2.2	N/A
		N/A
THE PERSON NAMED IN		N/A
		N/A
