Access Compliance Report

Public Rights-of-Way

(Curb Ramps)

Intersection ID: N/A	Main Street: BALLANTYNE_VILLAGE_DR	Cross Street: N/A	Location: N
ADA ID: 8487D7BBCB52	Ramp Type: Perp	Initial Pass/Fail: Fail	Overall Compliance: No
Codes/Mitigation Info/Possible Solution		Field Measurements/Component Compliance	
Severity Score: 22.5

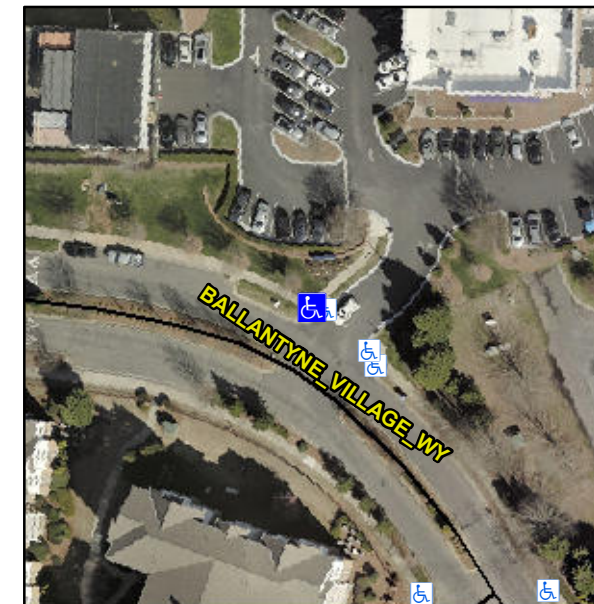
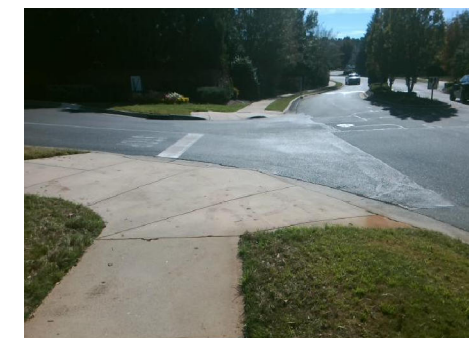
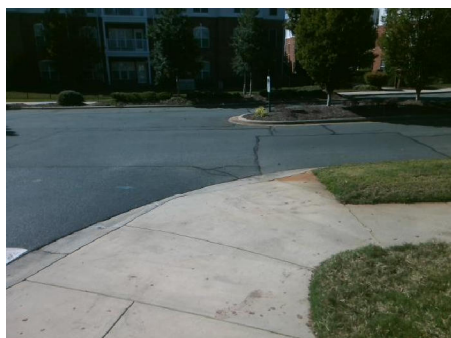
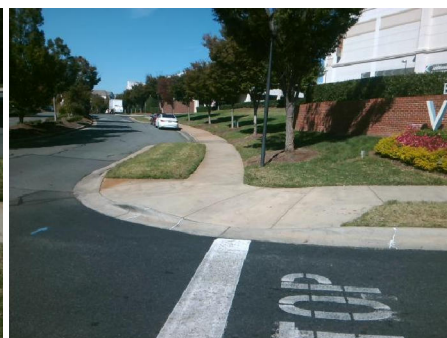
Not Found, R304.5.1, R304.2.2, R304.5.3

Compliance	Description	Data	Compliance	Description	Data
N/A	Ramp Length (in)	70.0	No	Ramp Slope (%)	9.4
No	Ramp Width (in)	41.0	No	Ramp XSlope (%)	4.7
N/A	Flare Type LT	N/A	N/A	Flare Type RT	N/A
N/A	Flare Slope LT (%)	N/A	N/A	Flare Slope RT (%)	N/A
N/A	Flare Traversable LT?	N/A	N/A	Flare Traversable RT?	N/A
N/A	Landing Length (in)	N/A	N/A	DWS Provided?	N/A
N/A	Landing Width (in)	N/A	N/A	DWS Contrast?	N/A
N/A	Landing Slope (%)	N/A	N/A	DWS Length (in)	N/A
N/A	Landing X Slope (%)	N/A	N/A	DWS Full Width?	N/A
N/A	Landing Curb? (Y/N)	N/A	N/A	DWS Offset (in)	N/A
N/A	Shared Landing?	N/A			
N/A	Gutter Ponding?	N/A	N/A	Gutter Slope (%)	N/A
N/A	Gutter Lip Ht (in)	N/A	N/A	Gutter X Slope (%)	N/A
N/A	Painted X Walk1?	No	N/A	Painted X Walk2?	N/A
	X Walk 1 Direction	To SE		X Walk 2 Direction	N/A
N/A	X Walk 1 Width (in)	N/A	N/A	X Walk 2 Width (in)	N/A
	X Walk 1 Slope (%)	0.8		X Walk 2 Slope (%)	N/A
	X Walk 1 X Slope (%)	1.1		X Walk 2 X Slope (%)	N/A

N/A	Ramp inside XWalk1?	N/A	N/A	Ramp inside XWalk2?	N/A
	Road Slope (%)	N/A	N/A	Clear Space?	N/A
	Road X Slope (%)	N/A	N/A	Clear Space to XWalk (in)	N/A
N/A	Any Obstructions?	N/A	N/A	Storm Grate/Utility Hazard?	N/A
	Obstruction Type			Storm Grate/Utility Type	
		N/A			N/A
			Yes	Surface Condition? (G/P)	Good

Remove & Replace Entire Ramp.
