# Access Compliance Report

## Public Rights-of-Way

### (Curb Ramps)

| Intersection ID: 51776 | Main Street: MCVAY_ST | Cross Street: ORANGE_ST | Location: W |

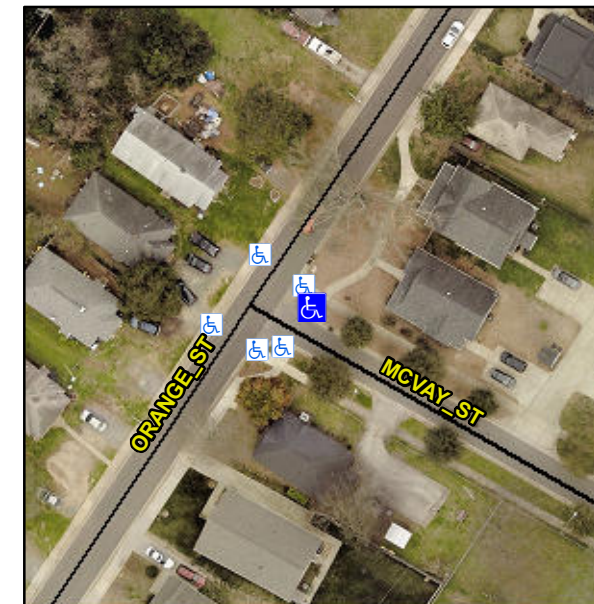
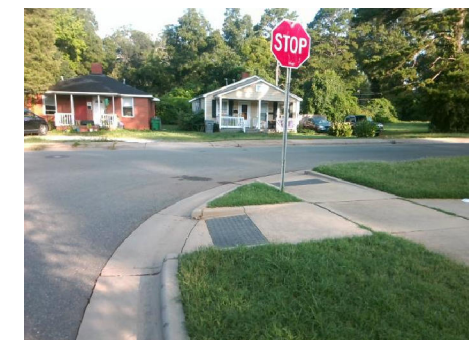
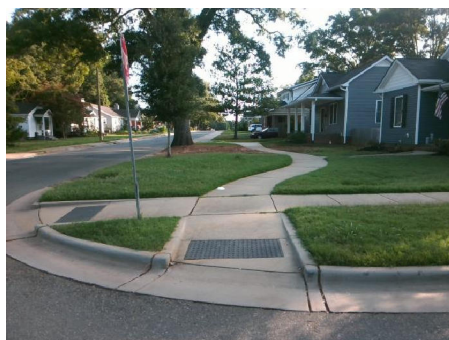
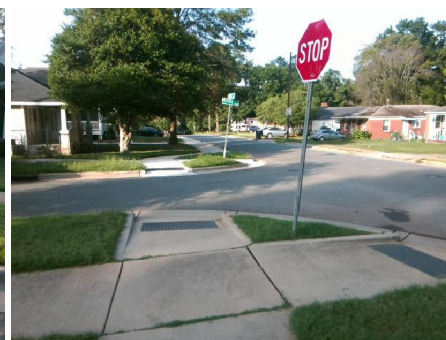
| ADA ID: 84AE0ABD2D22 | Ramp Type: Directional1 | Initial Pass/Fail: Fail | Overall Compliance: No |

**R304.5.3**

| Compliance | Description | Data | Compliance | Description | Data |
|---|---|---|---|---|---|
| No | Ramp XSlope (%) | 2.3 | | | |

**Remove & Replace Entire Ramp.**

\$ 1600.00
