Access Compliance Report Public Rights-of-Way (Curb Ramps)

Intersection ID: 44216Main Street:ROZZELLES_FERRY_RDCross Street:ROZZELLES_LANDING_DRLocation:NWADA ID: 84B2D7400861Ramp Type:PerpInitial Pass/Fail:FailOverall Compliance:NoSeverity Score:35

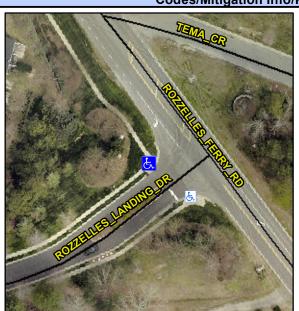
Field Measurements/Component Compliance						
Comp	liance Description	Data	Comp	liance Description	Data	
N/A	Ramp Length (in)	50.0	No	Ramp Slope (%)	12.9	
No	Ramp Width (in)	40.0	No	Ramp XSlope (%)	4.5	
N/A	Flare Type LT	N/A	N/A	Flare Type RT	N/A	
N/A	Flare Slope LT (%)	N/A	N/A	Flare Slope RT (%)	N/A	
N/A	Flare Traversable LT?	N/A	N/A	Flare Traversable RT?	N/A	
N/A	Landing Length (in)	N/A	N/A	DWS Provided?	N/A	
N/A	Landing Width (in)	N/A	N/A	DWS Contrast?	N/A	
N/A	Landing Slope (%)	N/A	N/A	DWS Length (in)	N/A	
N/A	Landing X Slope (%)	N/A	N/A	DWS Full Width?	N/A	
N/A	Landing Curb? (Y/N)	N/A	N/A	DWS Offset (in)	N/A	
N/A	Shared Landing?	N/A				
N/A	Gutter Ponding?	N/A	N/A	Gutter Slope (%)	N/A	
N/A	Gutter Lip Ht (in)	N/A	N/A	Gutter X Slope (%)	N/A	
N/A	Painted X Walk1?	No	N/A	Painted X Walk2?	N/A	
	X Walk 1 Direction	To SE		X Walk 2 Direction	N/A	
N/A	X Walk 1 Width (in)	N/A	N/A	X Walk 2 Width (in)	N/A	
	X Walk 1 Slope (%)	2.0		X Walk 2 Slope (%)	N/A

X Walk 1 X Slope (%)	3.2		X Walk 2 X Slope (%)	N/A	
N/A	Ramp inside XWalk1?	N/A	N/A	Ramp inside XWalk2?	N/A	
	Road Slope (%)	N/A	N/A	Clear Space?	N/A	
	Road X Slope (%)	N/A	N/A	Clear Space to XWalk (in)	N/A	
N/A	Any Obstructions?	N/A	N/A	Storm Grate/Utility Hazard?	N/A	
	Obstruction Type			Storm Grate/Utility Type		
		N/A			N/A	
			Yes	Surface Condition? (G/P)	Good	
the fact of

russible sululiuli			
Possible Solutions:	<u>c</u>		
Remove & Replace Entire Ramp.			
	N		
	N		
	N		
	N		
	N		
Surveyor Notes:	N		
N/A	N		
	N		
	N		
	N		
PROW/ADA:	N		
R304.5.1, R304.2.2, R304.5.3	N		
	N		
	N
