Access Compliance Report

Public Rights-of-Way

(Curb Ramps)

| Intersection ID: 21804 | Main Street: NOLLEY_CT | Cross Street: GALLERIA_BV | Location: SW |

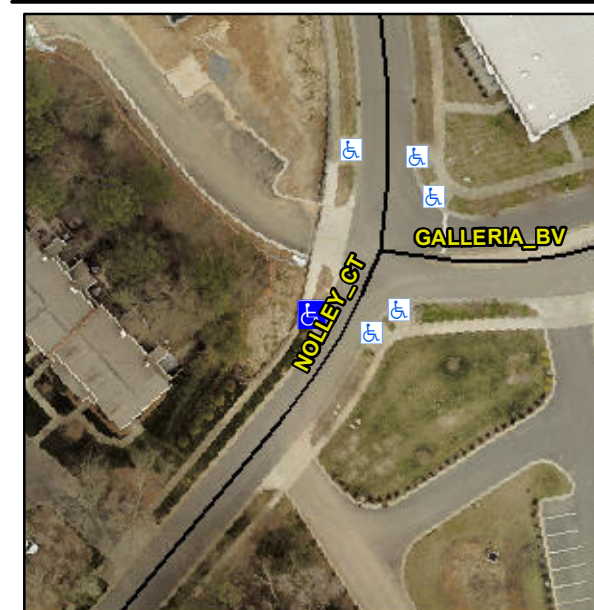
| ADA ID: 84B6C1C203E1 | Ramp Type: Perp | Initial Pass/Fail: Fail | Overall Compliance: No |

Not Found, R304.2.2

| Compliance | Description | Data | Compliance | Description | Data |
|---|---|---|---|---|---|
| N/A | Ramp Length (in) | 108.0 | No | Ramp Slope (%) | 9.2 |

Remove & Replace Entire Ramp.
