Intersection ID: 53888	Main Street: LOVELAND_DR	Cross Street: PAW_VALLEY_LN	Location:	SE
ADA ID: 84B996B46344	Ramp Type: Perp	Initial Pass/Fail: Fail	Overall Compliance: No	Severity Score: 8.75

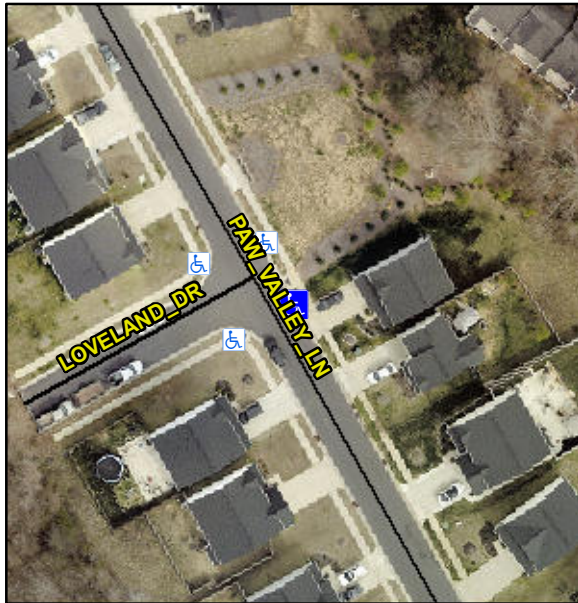
Not Found, R304.5.1

Compliance	Description	Data	Compliance	Description	Data
N/A	Ramp Length (in)	48.0	Yes	Ramp Slope (%)	7.7
No	Ramp Width (in)	47.5	Yes	Ramp XSlope (%)	1.6
N/A	Flare Type LT	N/A	N/A	Flare Type RT	N/A
N/A	Flare Slope LT (%)	N/A	N/A	Flare Slope RT (%)	N/A
N/A	Flare Traversable LT?	N/A	N/A	Flare Traversable RT?	N/A
N/A	Landing Length (in)	N/A	N/A	DWS Provided?	N/A
N/A	Landing Width (in)	N/A	N/A	DWS Contrast?	N/A
N/A	Landing Slope (%)	N/A	N/A	DWS Length (in)	N/A
N/A	Landing X Slope (%)	N/A	N/A	DWS Full Width?	N/A
N/A	Landing Curb? (Y/N)	N/A	N/A	DWS Offset (in)	N/A
N/A	Shared Landing?	N/A			
N/A	Gutter Ponding?	N/A	N/A	Gutter Slope (%)	N/A
N/A	Gutter Lip Ht (in)	N/A	N/A	Gutter X Slope (%)	N/A
N/A	Painted X Walk1?	No	N/A	Painted X Walk2?	N/A
	X Walk 1 Direction	To N		X Walk 2 Direction	N/A
N/A	X Walk 1 Width (in)	N/A	N/A	X Walk 2 Width (in)	N/A
	X Walk 1 Slope (%)	4.4		X Walk 2 Slope (%)	N/A
	X Walk 1 X Slope (%)	1.8		X Walk 2 X Slope (%)	N/A

Remove & Replace Entire Ramp.

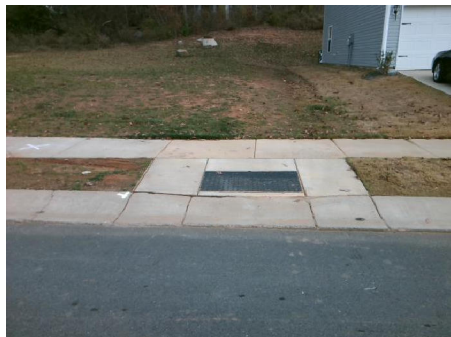
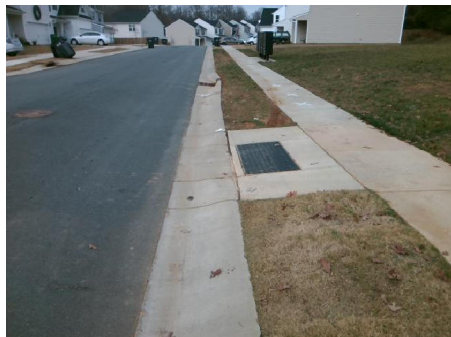
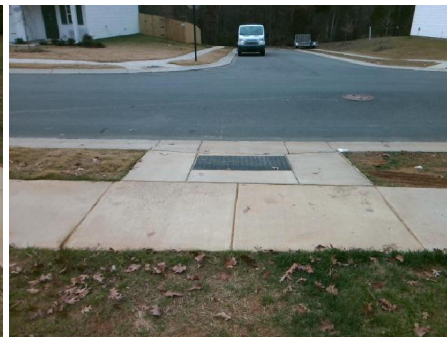
N/A	Ramp inside XWalk1?	N/A	N/A	Ramp inside XWalk2?	N/A
	Road Slope (%)	N/A	N/A	Clear Space?	N/A
	Road X Slope (%)	N/A	N/A	Clear Space to XWalk (in)	N/A
N/A	Any Obstructions?	N/A	N/A	Storm Grate/Utility Hazard?	N/A
	Obstruction Type			Storm Grate/Utility Type	
		N/A			N/A
			Yes	Surface Condition? (G/P)	Good
