# Access Compliance Report

## Public Rights-of-Way

### (Curb Ramps)

| Intersection ID: 10019678 | Main Street: ANDOVER_RD | Cross Street: N/A | Location: NE |

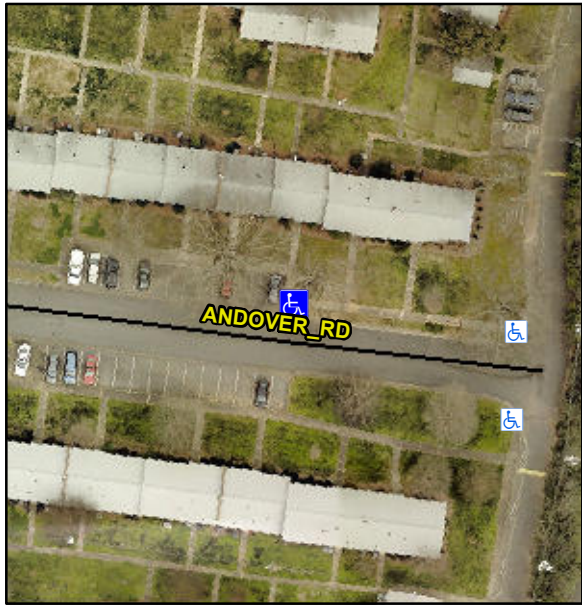
| ADA ID: 84C5BF280B83 | Ramp Type: Perp | Initial Pass/Fail: Fail | Overall Compliance: No |

| Codes/Mitigation Info/Possible Solution | | | Field Measurements/Component Compliance | | | | | |
|---|---|---|---|---|---|---|---|---|
| | Remove & Replace Entire Ramp. | | N/A | Ramp Length (in) | 48.0 | No | Ramp Slope (%) | 16.2 |
| | | | No | Ramp Width (in) | 36.0 | Yes | Ramp XSlope (%) | 2.3 |

| Codes/Mitigation Info/Possible Solution | | | Field Measurements/Component Compliance | | | | | |
|---|---|---|---|---|---|---|---|---|
| | Possible Solutions: | | Compliance | Description | Data | Compliance | Description | Data |
