Access Compliance Report

Public Rights-of-Way

(Curb Ramps)

Intersection ID: 13714	Main Street: HANOVER_ST	Cross Street: MCCLINTOCK_RD	Location: W
ADA ID: 84DA08C47939	Ramp Type: Perp	Initial Pass/Fail: Fail	Overall Compliance: No
Codes/Mitigation Info/Possible Solution			Severity Score: 10
			Field Measurements/Component Compliance

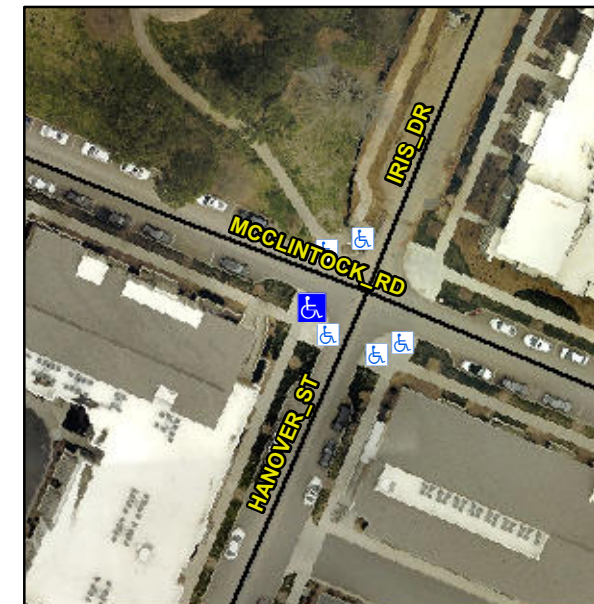
Compliance	Description	Data	Compliance	Description	Data
N/A	Ramp Length (in)	84.0	Yes	Ramp Slope (%)	6.2
No	Ramp Width (in)	47.5	No	Ramp XSlope (%)	3.4
N/A	Flare Type LT	N/A	N/A	Flare Type RT	N/A
N/A	Flare Slope LT (%)	N/A	N/A	Flare Slope RT (%)	N/A
N/A	Flare Traversable LT?	N/A	N/A	Flare Traversable RT?	N/A
N/A	Landing Length (in)	N/A	N/A	DWS Provided?	N/A
N/A	Landing Width (in)	N/A	N/A	DWS Contrast?	N/A
N/A	Landing Slope (%)	N/A	N/A	DWS Length (in)	N/A
N/A	Landing X Slope (%)	N/A	N/A	DWS Full Width?	N/A
N/A	Landing Curb? (Y/N)	N/A	N/A	DWS Offset (in)	N/A
N/A	Shared Landing?	N/A			
N/A	Gutter Ponding?	N/A	N/A	Gutter Slope (%)	N/A
N/A	Gutter Lip Ht (in)	N/A	N/A	Gutter X Slope (%)	N/A
N/A	Painted X Walk1?	No	N/A	Painted X Walk2?	N/A
	X Walk 1 Direction	To N		X Walk 2 Direction	N/A
N/A	X Walk 1 Width (in)	N/A	N/A	X Walk 2 Width (in)	N/A
	X Walk 1 Slope (%)	2.2		X Walk 2 Slope (%)	N/A
	X Walk 1 X Slope (%)	0.8		X Walk 2 X Slope (%)	N/A

N/A	Ramp inside XWalk1?	N/A	N/A	Ramp inside XWalk2?	N/A
	Road Slope (%)	N/A	N/A	Clear Space?	N/A
	Road X Slope (%)	N/A	N/A	Clear Space to XWalk (in)	N/A
N/A	Any Obstructions?	N/A	N/A	Storm Grate/Utility Hazard?	N/A
	Obstruction Type			Storm Grate/Utility Type	
		N/A			N/A
			Yes	Surface Condition? (G/P)	Good

Possible Solutions:

Remove & Replace Entire Ramp.

R304.5.1, R304.5.3
