Access Compliance Report Public Rights-of-Way (Curb Ramps)

Intersection ID: 10041519 Main Street: WEYMOUTH_LN **Cross Street: N/A** Location: NW ADA ID: 84F1027D9A1C Ramp Type: Perp Initial Pass/Fail: Fail **Overall Compliance: No Severity Score:** 12.5

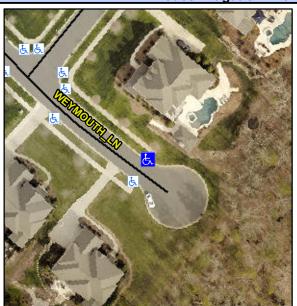
Field Measurements/Component Compliance						
Compl	iance Description	Data	Comp	iance Description	Data	
N/A	Ramp Length (in)	47.5	Yes	Ramp Slope (%)	7.2	
Yes	Ramp Width (in)	48.0	No	Ramp XSlope (%)	5.2	
N/A	Flare Type LT	N/A	N/A	Flare Type RT	N/A	
N/A	Flare Slope LT (%)	N/A	N/A	Flare Slope RT (%)	N/A	
N/A	Flare Traversable LT?	N/A	N/A	Flare Traversable RT?	N/A	
N/A	Landing Length (in)	N/A	N/A	DWS Provided?	N/A	
N/A	Landing Width (in)	N/A	N/A	DWS Contrast?	N/A	
N/A	Landing Slope (%)	N/A	N/A	DWS Length (in)	N/A	
N/A	Landing X Slope (%)	N/A	N/A	DWS Full Width?	N/A	
N/A	Landing Curb? (Y/N)	N/A	N/A	DWS Offset (in)	N/A	
N/A	Shared Landing?	N/A				
N/A	Gutter Ponding?	N/A	N/A	Gutter Slope (%)	N/A	
N/A	Gutter Lip Ht (in)	N/A	N/A	Gutter X Slope (%)	N/A	
N/A	Painted X Walk1?	No	N/A	Painted X Walk2?	N/A	
	X Walk 1 Direction	To SW		X Walk 2 Direction	N/A	
N/A	X Walk 1 Width (in)	N/A	N/A	X Walk 2 Width (in)	N/A	
	X Walk 1 Slope (%)	2.8		X Walk 2 Slope (%)	N/A

X Walk 1 X Slope (%)	2.3		X Walk 2 X Slope (%)	N/A	
N/A	Ramp inside XWalk1?	N/A	N/A	Ramp inside XWalk2?	N/A	
	Road Slope (%)	N/A	N/A	Clear Space?	N/A	
	Road X Slope (%)	N/A	N/A	Clear Space to XWalk (in)	N/A	
N/A	Any Obstructions?	N/A	N/A	Storm Grate/Utility Hazard?	N/A	
	Obstruction Type			Storm Grate/Utility Type		
		N/A			N/A	
			Yes	Surface Condition? (G/P)	Good

Possible Solutions: C N/ Remove & Replace Entire Ramp. Ye N/ Surveyor Notes: N/A PROW/ADA: Not Found, R304.5.3 N/ N/
