# Access Compliance Report

### (Curb Ramps)

| Intersection ID: 28718 | Main Street: DEARMON_RD | Cross Street: HAMPTON_PLACE_DR | Location: S |
| ADA ID: 84FF61AF0EFB | Ramp Type: Perp | Initial Pass/Fail: Fail | Overall Compliance: No |

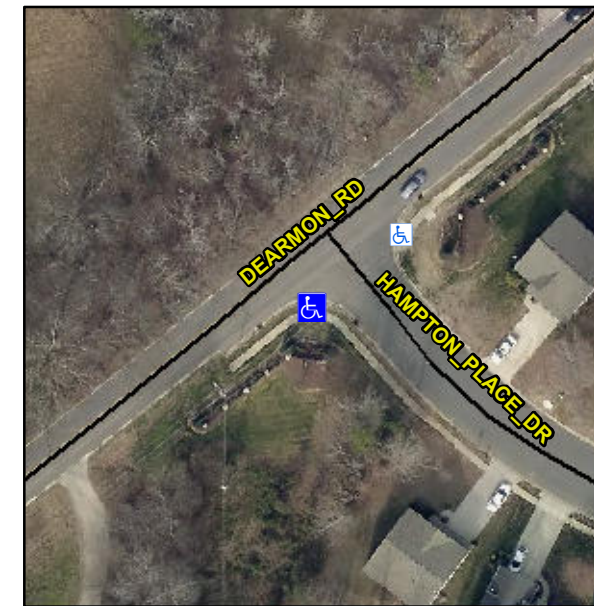
| Severity Score: 21.25 | | | |

**R304.5.1, R304.2.2**

| Compliance | Description | Data | Compliance | Description | Data |
|---|---|---|---|---|---|
| N/A | Ramp Length (in) | 48.0 | No | Ramp Slope (%) | 11.6 |
| No | Ramp Width (in) | 40.0 | Yes | Ramp XSlope (%) | 1.2 |

**Remove & Replace Entire Ramp.**

Total Cost: \$ 1850.00
