# Access Compliance Report

## Public Rights-of-Way

### (Curb Ramps)

Intersection ID: 45491	Main Street: GRASSY_CROPS_RD	Cross Street: TRIANGLE_PARK_RD	Location: SW
ADA ID: 851092D9C12B	Ramp Type: Combination1Diag	Initial Pass/Fail: Fail	Overall Compliance: No
		Severity Score: 0

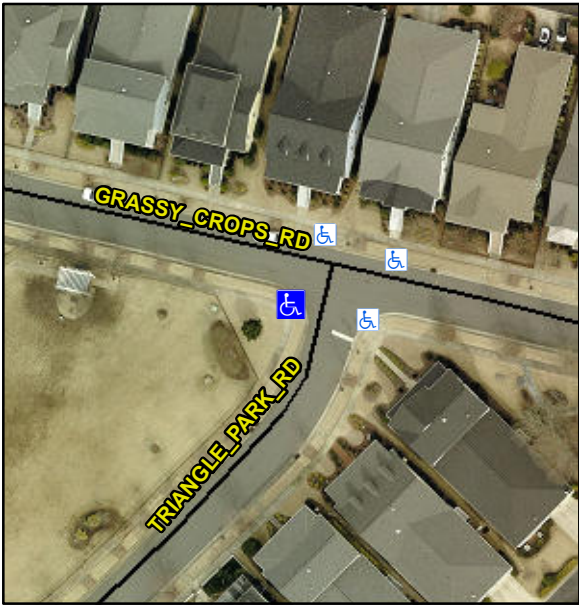
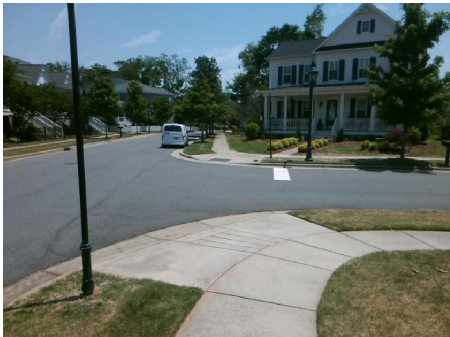
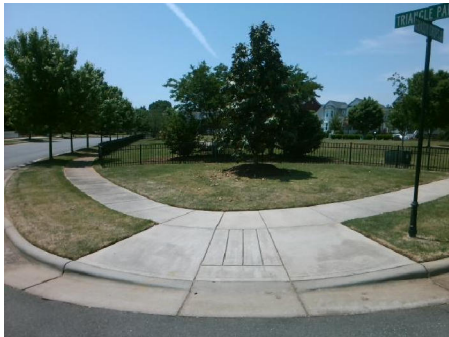
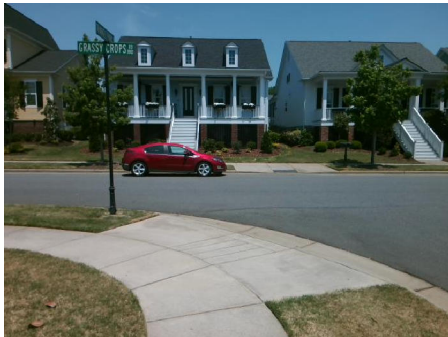
Possible Solutions:			Compliance	Description	Data	Compliance	Description	Data
	Remove & Replace Curb Ramp With Two New Directional Ramps or Equivalent.			N/A	Ramp Length LT (in)	27.0	N/A	Ramp Length RT (in)	45.0
				No	Ramp Width LT (in)	47.0	No	Ramp Width RT (in)	47.0
				Yes	Ramp Slope LT (%)	5.0	Yes	Ramp Slope RT (%)	5.0
				No	Ramp XSlope LT (%)	4.2	No	Ramp XSlope RT (%)	4.7
				N/A	Ramp Length (in)	71.0	No	Ramp Slope (%)	11.7
				No	Ramp Width (in)	36.0	No	Ramp XSlope (%)	3.8
				N/A	Flare Type LT	N/A	N/A	Flare Type RT	N/A
				N/A	Flare Slope LT (%)	N/A	N/A	Flare Slope RT (%)	N/A
				N/A	Flare Traversable LT?	N/A	N/A	Flare Traversable RT?	N/A
Surveyor Notes:			N/A	Landing Length (in)	N/A	N/A	DWS Provided?	N/A	
			N/A	Landing Width (in)	N/A	N/A	DWS Contrast?	N/A	
			N/A	Landing Slope (%)	N/A	N/A	DWS Length (in)	N/A

N/A	Landing X Slope (%)	N/A	N/A	DWS Full Width?	N/A	
			N/A	Landing Curb? (Y/N)	N/A	N/A	DWS Offset (in)	N/A	
			N/A	Shared Landing?	N/A				
			N/A	Gutter Ponding?	N/A	N/A	Gutter Slope (%)	N/A	
			N/A	Gutter Lip Ht (in)	N/A	N/A	Gutter X Slope (%)	N/A	
			N/A	Painted X Walk1?	No	N/A	Painted X Walk2?	No	
				X Walk 1 Direction	To E		X Walk 2 Direction	To N	
				X Walk 1 Width (in)	N/A		X Walk 2 Width (in)	N/A	
				X Walk 1 Slope (%)	2.4		X Walk 2 Slope (%)	3.0	
				X Walk 1 X Slope (%)	4.2		X Walk 2 X Slope (%)	0.7	
			N/A	Ramp inside XWalk1?	N/A	N/A	Ramp inside XWalk2?	N/A	
				Road Slope (%)	4.6		Clear Space?	N/A	
				Road X Slope (%)	2.7	N/A	Clear Space to XWalk (in)	N/A	
						N/A	Any Obstruction?	N/A	
							Obstruction Type	N/A	
						N/A	Storm Grate/Utility Hazard?	N/A	
							Storm Grate/Utility Type	N/A	
						Yes	Surface Condition? (G/P)	Good	
							Curb Slope (%)	16.8	
PROW/ADA:									
			Not Found, R304.5.1, R304.5.1, R304.2.2, R304.5.3
