Access Compliance Report Public Rights-of-Way (Curb Ramps)

Intersection ID: 27190 Main Street: BALLANTYNE_COMMONS_PY Cross Street: WOODVIEW_CR Location: NE

ADA ID: 8511A02A6FBB Ramp Type: Directional1 Initial Pass/Fail: Fail Overall Compliance: No Severity Score: 13.75

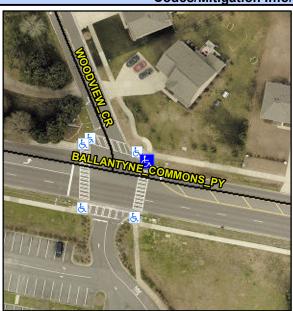
Possible Solution	Field Measurements/Component Compilance				
Possible Solutions:	Compliance Description		Data	Comp	liance Description
Remove & Replace Entire Ramp.	N/A	Ramp Length (in)	58.0	N/A	Grade Break?
·	Yes	Ramp Width (in)	70.0	N/A	Grade Break Slope (%)
	No	Ramp Slope (%)	8.9	N/A	Grade Break XSlope (%)
	No	Ramp XSlope (%)	2.1		
	N/A	Flare Type LT	N/A	N/A	Flare Type RT
	N/A	Flare Slope LT (%)	N/A	N/A	Flare Slope RT (%)
Surveyor Notes:	N/A	Flare Traversable LT?	N/A	N/A	Flare Traversable RT?
N/A	N/A	Landing Length (in)	0.0	N/A	DWS Provided?
	N/A	Landing Width (in)	0.0	N/A	DWS Contrast?
	N/A	Landing Slope (%)	0.0	N/A	DWS Length (in)
	N/A	Landing X Slope (%)	0.0	N/A	DWS Full Width?
PROW/ADA:	N/A	Landing Curb? (Y/N)	N/A	N/A	DWS Offset LT (in)
R304.2.2, R304.5.3	N/A	Shared Landing?	N/A	N/A	DWS Offset RT (in)
	N/A	Gutter Ponding?	0.0	N/A	Gutter Slope (%)
	N/A	Gutter Lip Ht (in)	0.0	N/A	Gutter X Slope (%)
	N/A	Painted X Walk1?	Yes		Road Slope (%)

X Walk 1 Direction	To S		Road X Slope (%)
		X Walk 1 Width (in)	112.0		Clear Space?
		X Walk 1 Slope (%)	6.0	N/A	Clear Space to XWalk (in)
		X Walk 1 X Slope (%)	0.7	N/A	Storm Grate/Utility Hazard?
	N/A	Ramp inside XWalk1?	Yes		Storm Grate/Utility Type
	N/A	Any Obstructions?	N/A
