## Access Compliance Report Public Rights-of-Way (Curb Ramps)

Intersection ID: 27314 Main Street: CHARTER\_HILLS\_RD Cross Street: WILD\_DOVE\_LN Location: SE

ADA ID: 8511B7C3D1DE Ramp Type: PerpDiag Initial Pass/Fail: Fail Overall Compliance: No Severity Score: 21.25

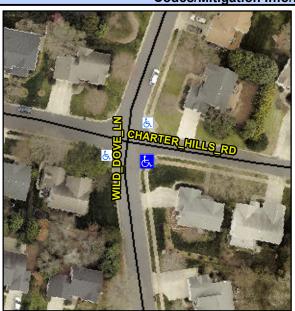
Not Found, R304.5.1, R304.5.3

riola modearomente/component compilarios						
Compli	empliance Description		Compliance Description		Data	
N/A	Ramp Length (in)	94.0	Yes	Ramp Slope (%)	5.2	
No	Ramp Width (in)	40.0	No	Ramp XSlope (%)	5.2	
N/A	Flare Type LT	N/A	N/A	Flare Type RT	N/A	
N/A	Flare Slope LT (%)	N/A	N/A	Flare Slope RT (%)	N/A	
N/A	Flare Traversable LT?	N/A	N/A	Flare Traversable RT?	N/A	
N/A	Landing Length (in)	N/A	N/A	DWS Provided?	N/A	
N/A	Landing Width (in)	N/A	N/A	DWS Contrast?	N/A	
N/A	Landing Slope (%)	N/A	N/A	DWS Length (in)	N/A	
N/A	Landing X Slope (%)	N/A	N/A	DWS Full Width?	N/A	
N/A	Landing Curb? (Y/N)	N/A	N/A	DWS Offset (in)	N/A	
N/A	Shared Landing?	N/A				
N/A	Gutter Ponding?	N/A	N/A	Gutter Slope (%)	N/A	
N/A	Gutter Lip Ht (in)	N/A	N/A	Gutter X Slope (%)	N/A	
N/A	Painted X Walk1?	No	N/A	Painted X Walk2?	No	
	X Walk 1 Direction	To N		X Walk 2 Direction	To NW	
N/A	X Walk 1 Width (in)	N/A	N/A	X Walk 2 Width (in)	N/A	
	X Walk 1 Slope (%)	5.3		X Walk 2 Slope (%)	1.3

X Walk 1 X Slope (%)	2.3		X Walk 2 X Slope (%)	6.4	
N/A	Ramp inside XWalk1?	N/A	N/A	Ramp inside XWalk2?	N/A	
	Road Slope (%)	3.5	N/A	Clear Space?	N/A	
	Road X Slope (%)	8.3	N/A	Clear Space to XWalk (in)	N/A	
N/A	Any Obstructions?	N/A	N/A	Storm Grate/Utility Hazard?	N/A

Remove & Replace Curb Ramp With
Two New Directional Ramps or
Equivalent.

Total Cost: \$ 3200.00
