Access Compliance Report

Public Rights-of-Way

(Curb Ramps)

Intersection ID: 15839	Main Street: DORCHESTER_PL	Cross Street: SEDGEFIELD_RD	Location: NE
ADA ID: 85126A95DB7F	Ramp Type: Directional1	Initial Pass/Fail: Fail	Overall Compliance: No
Severity Score: 22.5			
Codes/Mitigation Info/Possible Solution		Field Measurements/Component Compliance

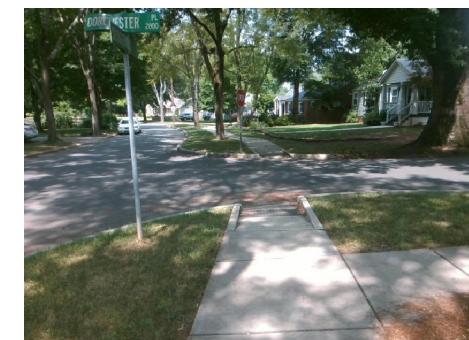
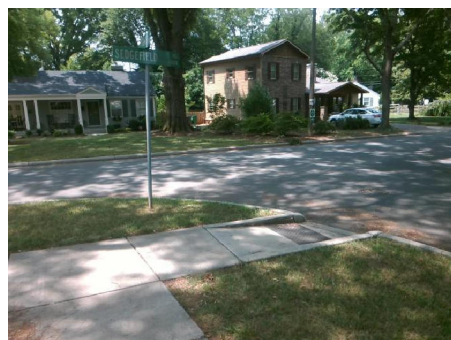
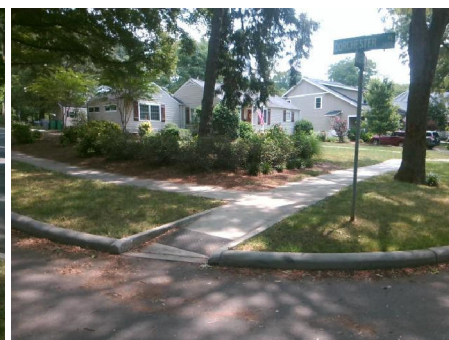
DAMAGED LT/RT FL

R304.5.1, R304.2.2, R304.5.3

Compliance	Description	Data	Compliance	Description	Data
N/A	Ramp Length (in)	64.0	N/A	Grade Break?	N/A
No	Ramp Width (in)	47.0	N/A	Grade Break Slope (%)	0.0
No	Ramp Slope (%)	10.5	N/A	Grade Break XSlope (%)	0.0
No	Ramp XSlope (%)	4.6			
N/A	Flare Type LT	N/A	N/A	Flare Type RT	N/A
N/A	Flare Slope LT (%)	N/A	N/A	Flare Slope RT (%)	0.0
N/A	Flare Traversable LT?	N/A	N/A	Flare Traversable RT?	N/A
N/A	Landing Length (in)	0.0	N/A	DWS Provided?	N/A
N/A	Landing Width (in)	0.0	N/A	DWS Contrast?	N/A
N/A	Landing Slope (%)	0.0	N/A	DWS Length (in)	N/A
N/A	Landing X Slope (%)	0.0	N/A	DWS Full Width?	N/A
N/A	Landing Curb? (Y/N)	N/A	N/A	DWS Offset LT (in)	N/A
N/A	Shared Landing?	N/A	N/A	DWS Offset RT (in)	N/A
N/A	Gutter Ponding?	0.0	N/A	Gutter Slope (%)	N/A
N/A	Gutter Lip Ht (in)	0.0	N/A	Gutter X Slope (%)	N/A
N/A	Painted X Walk1?	No		Road Slope (%)	0.1
	X Walk 1 Direction	To W		Road X Slope (%)	2.1
	X Walk 1 Width (in)	N/A		Clear Space?	N/A

X Walk 1 Slope (%)	0.1	N/A	Clear Space to XWalk (in)	N/A
	X Walk 1 X Slope (%)	2.1	N/A	Storm Grate/Utility Hazard?	N/A
N/A	Ramp inside XWalk1?	N/A		Storm Grate/Utility Type	
N/A	Any Obstructions?	N/A			N/A
	Obstruction Type		Yes	Surface Condition? (G/P)	Good
			N/A	Curb Slope (%)	4.7

Remove & Replace Entire Ramp.
