# Access Compliance Report

## Public Rights-of-Way

### (Curb Ramps)

Intersection ID: 12445	Main Street: CHESTNUT_AV	Cross Street: THE_PLAZA	Location: SE
ADA ID: 85153D5688C2	Ramp Type: Directional1	Initial Pass/Fail: Fail	Overall Compliance: No
Severity Score: 12.5			
Codes/Mitigation Info/Possible Solution		Field Measurements/Component Compliance

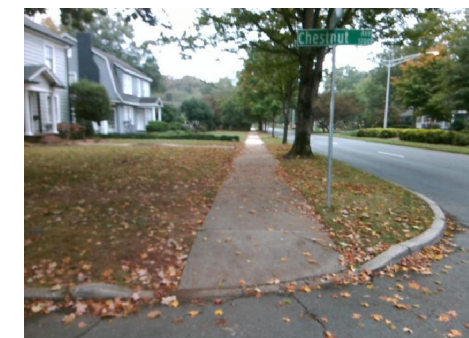
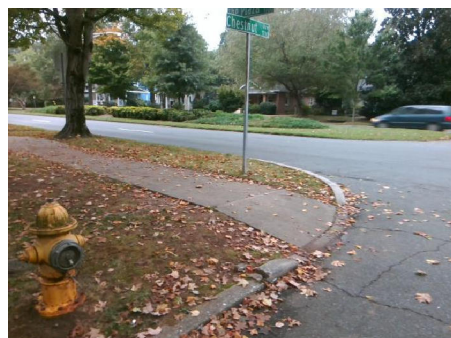
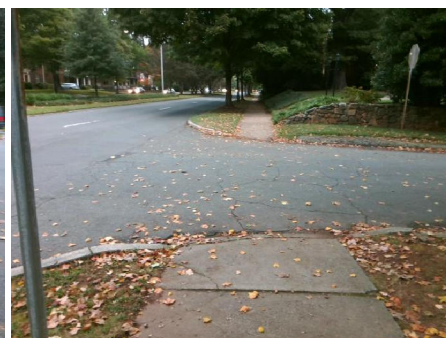
Compliance	Description	Data	Compliance	Description	Data
N/A	Ramp Length (in)	37.5	N/A	Grade Break?	N/A
Yes	Ramp Width (in)	66.5	N/A	Grade Break Slope (%)	0.0
No	Ramp Slope (%)	11.3	N/A	Grade Break XSlope (%)	0.0
Yes	Ramp XSlope (%)	1.5			
N/A	Flare Type LT	N/A	N/A	Flare Type RT	N/A
N/A	Flare Slope LT (%)	N/A	N/A	Flare Slope RT (%)	0.0
N/A	Flare Traversable LT?	N/A	N/A	Flare Traversable RT?	N/A
N/A	Landing Length (in)	0.0	N/A	DWS Provided?	N/A
N/A	Landing Width (in)	0.0	N/A	DWS Contrast?	N/A
N/A	Landing Slope (%)	0.0	N/A	DWS Length (in)	N/A
N/A	Landing X Slope (%)	0.0	N/A	DWS Full Width?	N/A
N/A	Landing Curb? (Y/N)	N/A	N/A	DWS Offset LT (in)	N/A
N/A	Shared Landing?	N/A	N/A	DWS Offset RT (in)	N/A
N/A	Gutter Ponding?	0.0	N/A	Gutter Slope (%)	N/A
N/A	Gutter Lip Ht (in)	0.5	N/A	Gutter X Slope (%)	N/A
N/A	Painted X Walk1?	No		Road Slope (%)	4.3
	X Walk 1 Direction	To N		Road X Slope (%)	1.3
	X Walk 1 Width (in)	N/A		Clear Space?	N/A

X Walk 1 Slope (%)	4.3	N/A	Clear Space to XWalk (in)	N/A
	X Walk 1 X Slope (%)	1.3	N/A	Storm Grate/Utility Hazard?	N/A
N/A	Ramp inside XWalk1?	N/A		Storm Grate/Utility Type	
N/A	Any Obstructions?	N/A			N/A
	Obstruction Type		Yes	Surface Condition? (G/P)	Good
			N/A	Curb Slope (%)	4.6

**Remove & Replace Entire Ramp.**
