Access Compliance Report

Public Rights-of-Way (Curb Ramps)

Intersection ID: 10990	Main Street: BARRINGTON_DR	Cross Street: LANECREST_DR	Location: NW
ADA ID: 85154E53C782	Ramp Type: Combination1	Initial Pass/Fail: Fail	Overall Compliance: No
Codes/Mitigation Info/Possible Solution		Field Measurements/Component Compliance

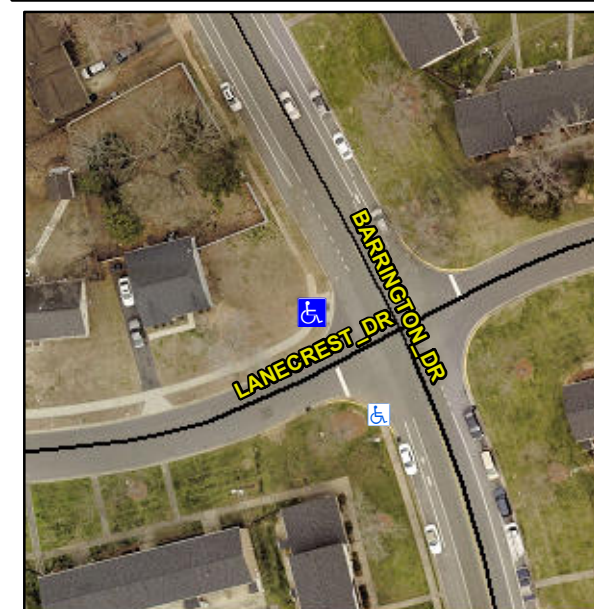
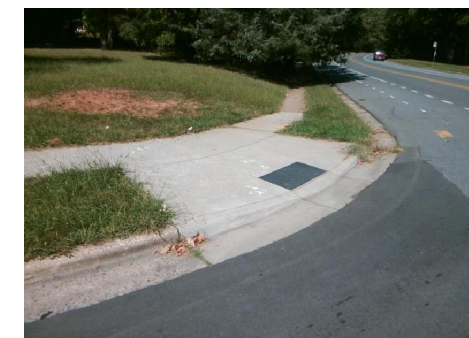
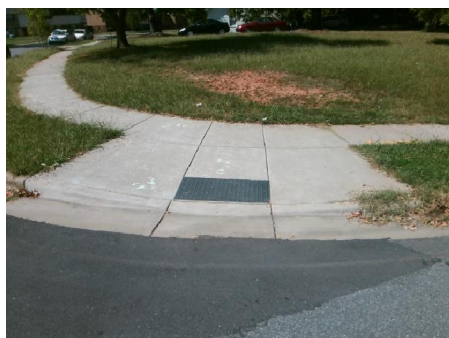
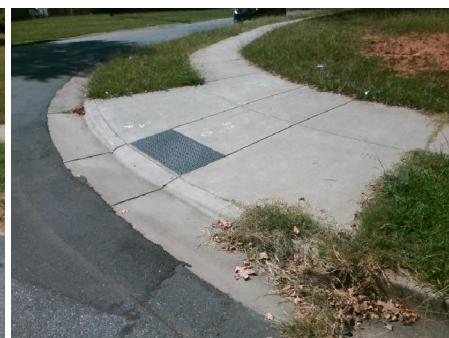
**Not Found, R304.5.1, R304.5.3,
R304.3.2**

Compliance	Description	Data	Compliance	Description	Data
N/A	Ramp Length LT (in)	48.0	N/A	Ramp Length RT (in)	50.0
Yes	Ramp Width LT (in)	48.0	Yes	Ramp Width RT (in)	48.0
No	Ramp Slope LT (%)	9.0	Yes	Ramp Slope RT (%)	6.0
No	Ramp XSlope LT (%)	4.6	No	Ramp XSlope RT (%)	5.1
N/A	Ramp Length (in)	72.0	Yes	Ramp Slope (%)	8.3
No	Ramp Width (in)	44.5	No	Ramp XSlope (%)	5.7
N/A	Flare Type LT	N/A	N/A	Flare Type RT	N/A
N/A	Flare Slope LT (%)	N/A	N/A	Flare Slope RT (%)	N/A
N/A	Flare Traversable LT?	N/A	N/A	Flare Traversable RT?	N/A
N/A	Landing Length (in)	N/A	N/A	DWS Provided?	N/A
N/A	Landing Width (in)	N/A	N/A	DWS Contrast?	N/A
N/A	Landing Slope (%)	N/A	N/A	DWS Length (in)	N/A
N/A	Landing X Slope (%)	N/A	N/A	DWS Full Width?	N/A
N/A	Landing Curb? (Y/N)	N/A	N/A	DWS Offset (in)	N/A
N/A	Shared Landing?	N/A			
N/A	Gutter Ponding?	N/A	N/A	Gutter Slope (%)	N/A
N/A	Gutter Lip Ht (in)	N/A	N/A	Gutter X Slope (%)	N/A
N/A	Painted X Walk1?	No	N/A	Painted X Walk2?	N/A

X Walk 1 Direction	To SE		X Walk 2 Direction	N/A
	X Walk 1 Width (in)	N/A		X Walk 2 Width (in)	N/A
	X Walk 1 Slope (%)	0.9		X Walk 2 Slope (%)	N/A
	X Walk 1 X Slope (%)	5.7		X Walk 2 X Slope (%)	N/A
N/A	Ramp inside XWalk1?	N/A	N/A	Ramp inside XWalk2?	N/A
	Road Slope (%)	N/A		Clear Space?	N/A
	Road X Slope (%)	N/A	N/A	Clear Space to XWalk (in)	N/A
			N/A	Any Obstruction?	N/A
				Obstruction Type	N/A
			N/A	Storm Grate/Utility Hazard?	N/A
				Storm Grate/Utility Type	N/A
			Yes	Surface Condition? (G/P)	Good
				Curb Slope (%)	31.3

Remove & Replace Entire Ramp.
