Access Compliance Report

Public Rights-of-Way

(Curb Ramps)

Intersection ID: 15072	Main Street: DILWORTH_RD_EAST	Cross Street: E WORTHINGTON AV	Location: W
ADA ID: 8520C4657B15	Ramp Type: Perp	Initial Pass/Fail: Fail	Overall Compliance: No
Severity Score: 13.75			
Codes/Mitigation Info/Possible Solution		Field Measurements/Component Compliance

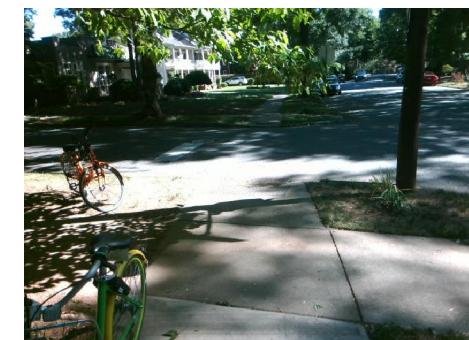
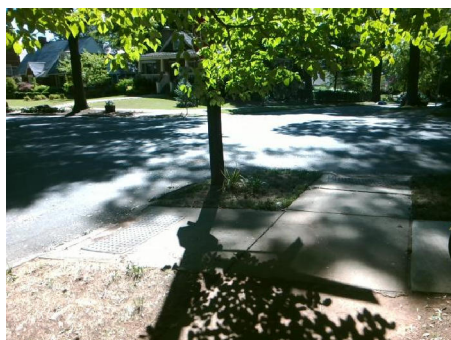
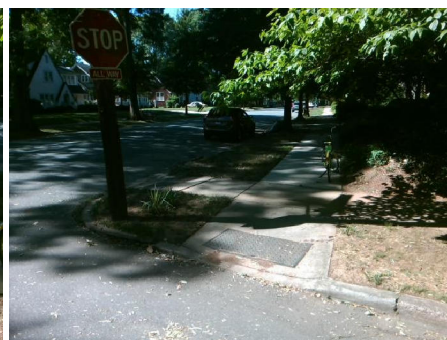
Not Found, R304.2.2, R304.5.3

Compliance	Description	Data	Compliance	Description	Data
N/A	Ramp Length (in)	80.0	No	Ramp Slope (%)	9.0
Yes	Ramp Width (in)	48.0	No	Ramp XSlope (%)	4.5
N/A	Flare Type LT	N/A	N/A	Flare Type RT	N/A
N/A	Flare Slope LT (%)	N/A	N/A	Flare Slope RT (%)	N/A
N/A	Flare Traversable LT?	N/A	N/A	Flare Traversable RT?	N/A
N/A	Landing Length (in)	N/A	N/A	DWS Provided?	N/A
N/A	Landing Width (in)	N/A	N/A	DWS Contrast?	N/A
N/A	Landing Slope (%)	N/A	N/A	DWS Length (in)	N/A
N/A	Landing X Slope (%)	N/A	N/A	DWS Full Width?	N/A
N/A	Landing Curb? (Y/N)	N/A	N/A	DWS Offset (in)	N/A
N/A	Shared Landing?	N/A			
N/A	Gutter Ponding?	N/A	N/A	Gutter Slope (%)	N/A
N/A	Gutter Lip Ht (in)	N/A	N/A	Gutter X Slope (%)	N/A
N/A	Painted X Walk1?	No	N/A	Painted X Walk2?	N/A
	X Walk 1 Direction	To NE		X Walk 2 Direction	N/A
N/A	X Walk 1 Width (in)	N/A	N/A	X Walk 2 Width (in)	N/A
	X Walk 1 Slope (%)	2.2		X Walk 2 Slope (%)	N/A
	X Walk 1 X Slope (%)	0.1		X Walk 2 X Slope (%)	N/A

N/A	Ramp inside XWalk1?	N/A	N/A	Ramp inside XWalk2?	N/A
	Road Slope (%)	N/A	N/A	Clear Space?	N/A
	Road X Slope (%)	N/A	N/A	Clear Space to XWalk (in)	N/A
N/A	Any Obstructions?	N/A	N/A	Storm Grate/Utility Hazard?	N/A
	Obstruction Type			Storm Grate/Utility Type	
		N/A			N/A
		Yes		Surface Condition? (G/P)	Good

Remove & Replace Entire Ramp.

Total Cost: \$ 1850.00
