# Access Compliance Report

## Public Rights-of-Way

### (Curb Ramps)

Intersection ID: 44268	Main Street: ISAAC_HUNTER_DR	Cross Street: EMILY_HOPE_DR	Location: E
ADA ID: 853A7615E4E5	Ramp Type: PerpDiag	Initial Pass/Fail: Fail	Overall Compliance: No
Codes/Mitigation Info/Possible Solution		Field Measurements/Component Compliance	
Severity Score: 8.75

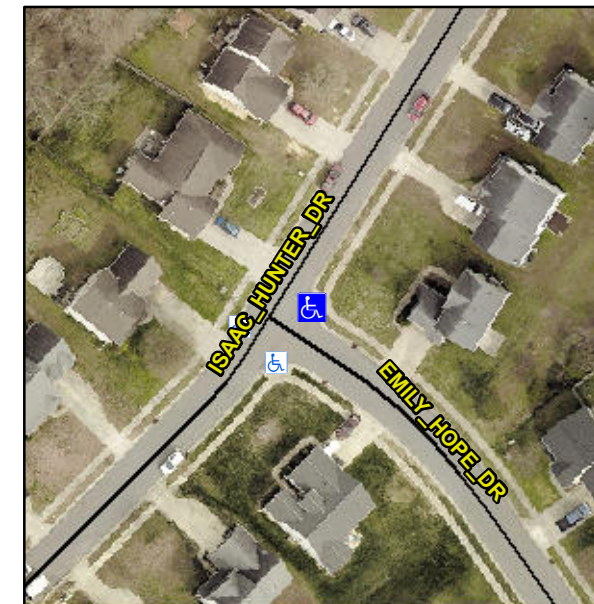
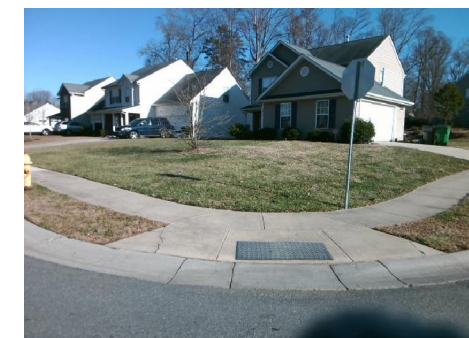
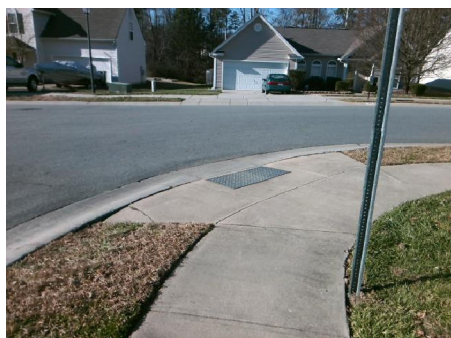
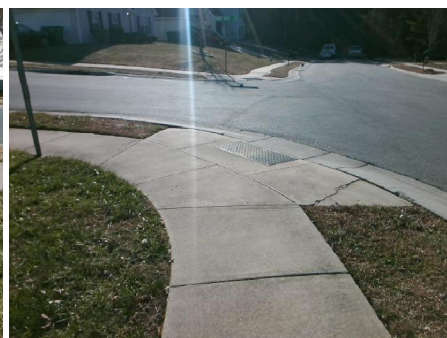
**Not Found, R304.5.1**

Compliance	Description	Data	Compliance	Description	Data
N/A	Ramp Length (in)	48.5	Yes	Ramp Slope (%)	7.6
No	Ramp Width (in)	46.0	Yes	Ramp XSlope (%)	0.1
N/A	Flare Type LT	N/A	N/A	Flare Type RT	N/A
N/A	Flare Slope LT (%)	N/A	N/A	Flare Slope RT (%)	N/A
N/A	Flare Traversable LT?	N/A	N/A	Flare Traversable RT?	N/A
N/A	Landing Length (in)	N/A	N/A	DWS Provided?	N/A
N/A	Landing Width (in)	N/A	N/A	DWS Contrast?	N/A
N/A	Landing Slope (%)	N/A	N/A	DWS Length (in)	N/A
N/A	Landing X Slope (%)	N/A	N/A	DWS Full Width?	N/A
N/A	Landing Curb? (Y/N)	N/A	N/A	DWS Offset (in)	N/A
N/A	Shared Landing?	N/A			
N/A	Gutter Ponding?	N/A	N/A	Gutter Slope (%)	N/A
N/A	Gutter Lip Ht (in)	N/A	N/A	Gutter X Slope (%)	N/A
N/A	Painted X Walk1?	No	N/A	Painted X Walk2?	No
	X Walk 1 Direction	To NW		X Walk 2 Direction	To SW
N/A	X Walk 1 Width (in)	N/A	N/A	X Walk 2 Width (in)	N/A
	X Walk 1 Slope (%)	2.2		X Walk 2 Slope (%)	0.5
	X Walk 1 X Slope (%)	0.3		X Walk 2 X Slope (%)	1.0

N/A	Ramp inside XWalk1?	N/A	N/A	Ramp inside XWalk2?	N/A
	Road Slope (%)	1.3	N/A	Clear Space?	N/A
	Road X Slope (%)	1.3	N/A	Clear Space to XWalk (in)	N/A
N/A	Any Obstructions?	N/A	N/A	Storm Grate/Utility Hazard?	N/A
	Obstruction Type			Storm Grate/Utility Type	
		N/A			N/A
			Yes	Surface Condition? (G/P)	Good

Possible Solutions:

**Remove & Replace Curb Ramp With Two New Directional Ramps or Equivalent.**
