Access Compliance Report

Public Rights-of-Way

(Curb Ramps)

Intersection ID: 53750	Main Street: SPRINGWOOD_ESTATE_DR	Cross Street: SAGAMORE_HILL_DR	Location: NW
ADA ID: 854AEFC9C33D	Ramp Type: Perp	Initial Pass/Fail: Fail	Overall Compliance: No
Severity Score: 10			
Codes/Mitigation Info/Possible Solution		Field Measurements/Component Compliance

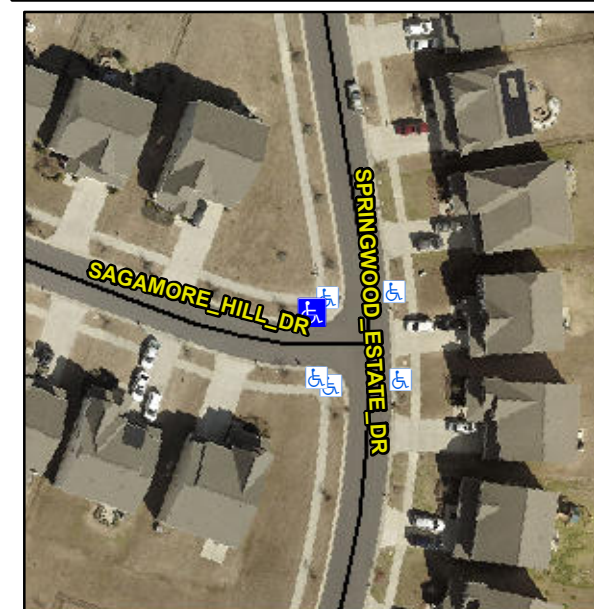
Not Found, R304.5.1, R304.5.3

Compliance	Description	Data	Compliance	Description	Data
N/A	Ramp Length (in)	99.0	Yes	Ramp Slope (%)	6.8
No	Ramp Width (in)	46.0	No	Ramp XSlope (%)	2.8
N/A	Flare Type LT	N/A	N/A	Flare Type RT	N/A
N/A	Flare Slope LT (%)	N/A	N/A	Flare Slope RT (%)	N/A
N/A	Flare Traversable LT?	N/A	N/A	Flare Traversable RT?	N/A
N/A	Landing Length (in)	N/A	N/A	DWS Provided?	N/A
N/A	Landing Width (in)	N/A	N/A	DWS Contrast?	N/A
N/A	Landing Slope (%)	N/A	N/A	DWS Length (in)	N/A
N/A	Landing X Slope (%)	N/A	N/A	DWS Full Width?	N/A
N/A	Landing Curb? (Y/N)	N/A	N/A	DWS Offset (in)	N/A
N/A	Shared Landing?	N/A			
N/A	Gutter Ponding?	N/A	N/A	Gutter Slope (%)	N/A
N/A	Gutter Lip Ht (in)	N/A	N/A	Gutter X Slope (%)	N/A
N/A	Painted X Walk1?	No	N/A	Painted X Walk2?	N/A
	X Walk 1 Direction	To S		X Walk 2 Direction	N/A
N/A	X Walk 1 Width (in)	N/A	N/A	X Walk 2 Width (in)	N/A
	X Walk 1 Slope (%)	3.8		X Walk 2 Slope (%)	N/A
	X Walk 1 X Slope (%)	4.5		X Walk 2 X Slope (%)	N/A

N/A	Ramp inside XWalk1?	N/A	N/A	Ramp inside XWalk2?	N/A
	Road Slope (%)	N/A	N/A	Clear Space?	N/A
	Road X Slope (%)	N/A	N/A	Clear Space to XWalk (in)	N/A
N/A	Any Obstructions?	N/A	N/A	Storm Grate/Utility Hazard?	N/A
	Obstruction Type			Storm Grate/Utility Type	
		N/A			N/A
			Yes	Surface Condition? (G/P)	Good

Remove & Replace Entire Ramp.
