Access Compliance Report

Public Rights-of-Way

(Curb Ramps)

Intersection ID: 15351	Main Street: BARRINGER_DR	Cross Street: CLANTON_RD	Location: NW
ADA ID: 85671BF7487A	Ramp Type: BlendTrans2	Initial Pass/Fail: Pass	Overall Compliance: No
Severity Score: 0			
Codes/Mitigation Info/Possible Solution		Field Measurements/Component Compliance

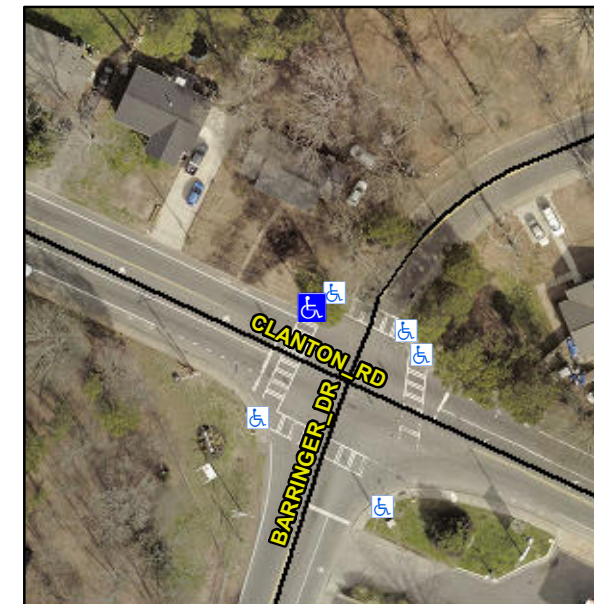
Not Found, R304.2.3, R305.2, R302.7

Compliance	Description	Data	Compliance	Description	Data
N/A	Ramp Length (in)	72.0	Yes	BlendTrans Slope (%)	4.8
Yes	Ramp Width (in)	48.0	Yes	BlendTrans XSlope (%)	1.9
N/A	Flare Type LT	Sloped	N/A	Flare Type RT	Sloped
N/A	Flare Slope LT (%)	N/A	No	Flare Slope RT (%)	N/A
N/A	Flare Traversable LT?	No	N/A	Flare Traversable RT?	Yes
N/A	Landing Length (in)	N/A	Yes	DWS Provided?	Yes
N/A	Landing Width (in)	N/A	Yes	DWS Contrast?	Yes
N/A	Landing Slope (%)	N/A	Yes	DWS Length (in)	24.0
N/A	Landing X Slope (%)	N/A	Yes	DWS Full Width?	Yes
N/A	Landing Curb? (Y/N)	No	No	DWS Offset (in)	6.0
N/A	Shared Landing?	No			
No	Gutter Ponding?	Yes	Yes	Gutter Slope (%)	2.1
Yes	Gutter Lip Ht (in)	0.0	Yes	Gutter X Slope (%)	1.8
N/A	Painted X Walk1?	Yes	N/A	Painted X Walk2?	N/A
	X Walk 1 Direction	To SW		X Walk 2 Direction	N/A
	X Walk 1 Width (in)	110.0		X Walk 2 Width (in)	N/A
	X Walk 1 Slope (%)	6.1		X Walk 2 Slope (%)	N/A
	X Walk 1 X Slope (%)	3.9		X Walk 2 X Slope (%)	N/A

Yes	Ramp inside XWalk1?	Yes	N/A	Ramp inside XWalk2?	N/A
	Road Slope (%)	3.9		Clear Space?	Yes
	Road X Slope (%)	6.1	N/A	Clear Space to XWalk (in)	N/A
Yes	Any Obstructions?	No	Yes	Storm Grate/Utility Hazard?	No
	Obstruction Type			Storm Grate/Utility Type	
		N/A			N/A
			Yes	Surface Condition? (G/P)	Good
			No	Curb Slope (%)	11.1

Possible Solutions:

Remove & Replace Curb Ramp With Two New Directional Ramps or Equivalent.

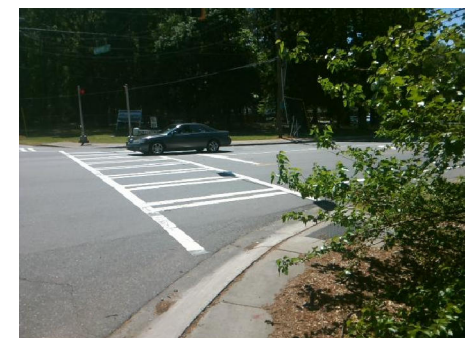
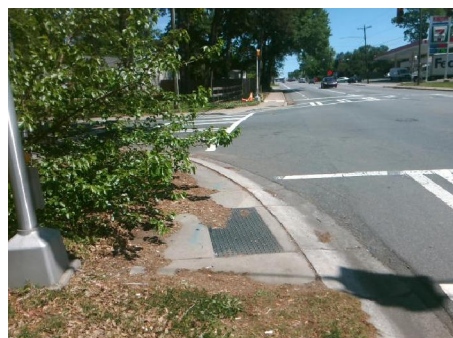
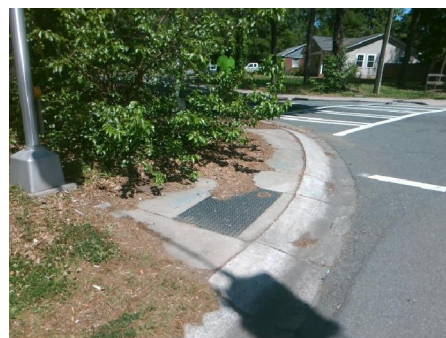
Street 1 Name CLANTON RD

Stop Condition-Street 1 Signal
