# Access Compliance Report

## Public Rights-of-Way

### (Curb Ramps)

Intersection ID: 16513	Main Street: BILTMORE_DR	Cross Street: COLVILLE_RD	Location: NW
ADA ID: 8572489F2500	Ramp Type: Perp	Initial Pass/Fail: Fail	Overall Compliance: No
Codes/Mitigation Info/Possible Solution		Field Measurements/Component Compliance	
Severity Score: 12.5

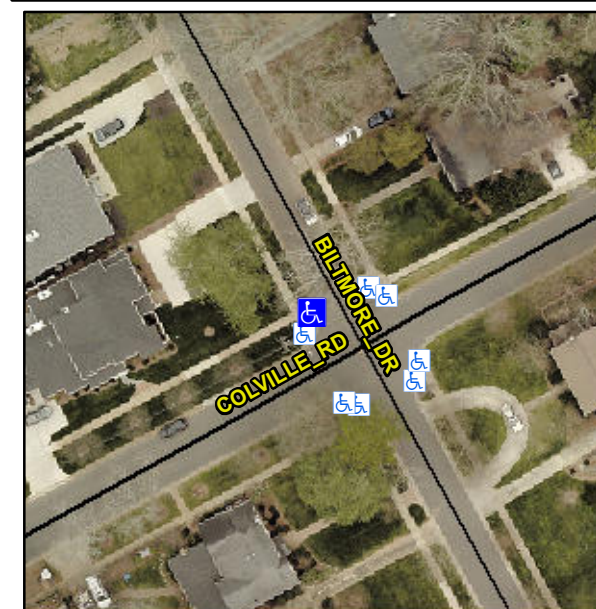
Compliance	Description	Data	Compliance	Description	Data
N/A	Ramp Length (in)	77.0	No	Ramp Slope (%)	9.1
Yes	Ramp Width (in)	48.0	Yes	Ramp XSlope (%)	1.6
N/A	Flare Type LT	N/A	N/A	Flare Type RT	N/A
N/A	Flare Slope LT (%)	N/A	N/A	Flare Slope RT (%)	N/A
N/A	Flare Traversable LT?	N/A	N/A	Flare Traversable RT?	N/A
N/A	Landing Length (in)	N/A	N/A	DWS Provided?	N/A
N/A	Landing Width (in)	N/A	N/A	DWS Contrast?	N/A
N/A	Landing Slope (%)	N/A	N/A	DWS Length (in)	N/A
N/A	Landing X Slope (%)	N/A	N/A	DWS Full Width?	N/A
N/A	Landing Curb? (Y/N)	N/A	N/A	DWS Offset (in)	N/A
N/A	Shared Landing?	N/A			
N/A	Gutter Ponding?	N/A	N/A	Gutter Slope (%)	N/A
N/A	Gutter Lip Ht (in)	N/A	N/A	Gutter X Slope (%)	N/A
N/A	Painted X Walk1?	No	N/A	Painted X Walk2?	N/A
	X Walk 1 Direction	To NE		X Walk 2 Direction	N/A
N/A	X Walk 1 Width (in)	N/A	N/A	X Walk 2 Width (in)	N/A
	X Walk 1 Slope (%)	3.0		X Walk 2 Slope (%)	N/A
	X Walk 1 X Slope (%)	0.4		X Walk 2 X Slope (%)	N/A

N/A	Ramp inside XWalk1?	N/A	N/A	Ramp inside XWalk2?	N/A
	Road Slope (%)	N/A	N/A	Clear Space?	N/A
	Road X Slope (%)	N/A	N/A	Clear Space to XWalk (in)	N/A
N/A	Any Obstructions?	N/A	N/A	Storm Grate/Utility Hazard?	N/A
	Obstruction Type			Storm Grate/Utility Type	
		N/A			N/A
			Yes	Surface Condition? (G/P)	Good

Possible Solutions:

**Remove & Replace Entire Ramp.**

**R304.2.2**

**\$ 1850.00**
