Access Compliance Report

Public Rights-of-Way

(Curb Ramps)

| Intersection ID: 8971 | Main Street: FAIRMONT_ST | Cross Street: GRIER_AV | Location: NW |

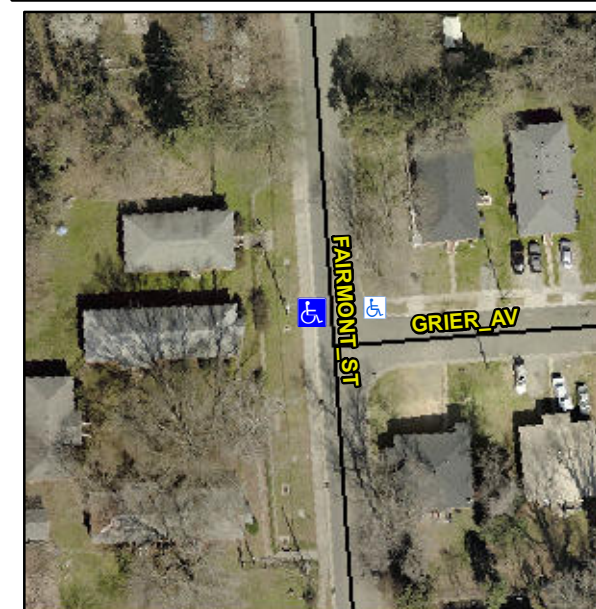
| ADA ID: 8575C47288E5 | Ramp Type: Perp | Initial Pass/Fail: Pass | Overall Compliance: No |
| Severity Score: 0.25 | | | |

**Not Found, R304.5.3, R304.2.2-Perp,
R304.3.2-Para**

| Compliance | Description | Data | Compliance | Description | Data |
|---|---|---|---|---|---|
| Yes | Ramp Width (in) | 48.0 | No | Ramp XSlope (%) | 2.4 |
| No | Landing Slope (%) | 3.9 | Yes | DWS Length (in) | 24.0 |
| No | Landing X Slope (%) | 2.6 | Yes | DWS Full Width? | Yes |
| Yes | Gutter Lip Ht (in) | 0.0 | No | Gutter X Slope (%) | 2.1 |

**Remove & Replace Entire Ramp.
Remove & Replace Gutter.**

Total Cost: \$ 2600.00
