Access Compliance Report

Public Rights-of-Way

(Curb Ramps)

Intersection ID: 9490	Main Street: BARRINGTON_DR	Cross Street: CRAFTSBURY_DR	Location: S
ADA ID: 85839F196C30	Ramp Type: Perp	Initial Pass/Fail: Fail	Overall Compliance: No
Severity Score: 8.75			
Codes/Mitigation Info/Possible Solution		Field Measurements/Component Compliance

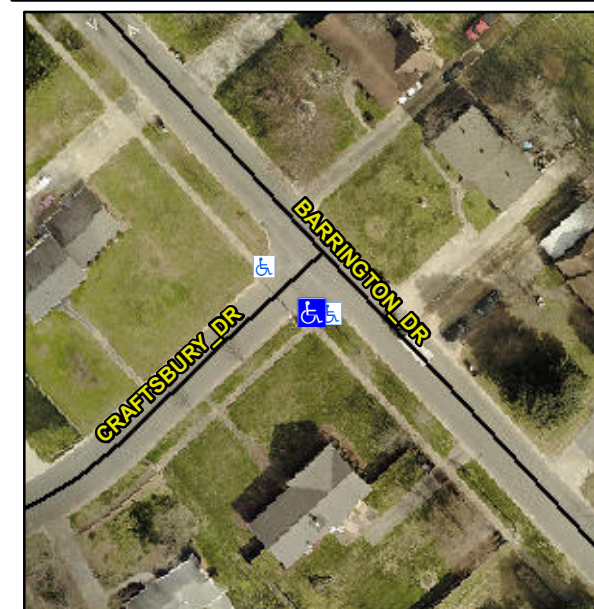
Not Found, R304.5.1

Compliance	Description	Data	Compliance	Description	Data
N/A	Ramp Length (in)	65.5	Yes	Ramp Slope (%)	7.7
No	Ramp Width (in)	45.0	Yes	Ramp XSlope (%)	1.8
N/A	Flare Type LT	N/A	N/A	Flare Type RT	N/A
N/A	Flare Slope LT (%)	N/A	N/A	Flare Slope RT (%)	N/A
N/A	Flare Traversable LT?	N/A	N/A	Flare Traversable RT?	N/A
N/A	Landing Length (in)	N/A	N/A	DWS Provided?	N/A
N/A	Landing Width (in)	N/A	N/A	DWS Contrast?	N/A
N/A	Landing Slope (%)	N/A	N/A	DWS Length (in)	N/A
N/A	Landing X Slope (%)	N/A	N/A	DWS Full Width?	N/A
N/A	Landing Curb? (Y/N)	N/A	N/A	DWS Offset (in)	N/A
N/A	Shared Landing?	N/A			
N/A	Gutter Ponding?	N/A	N/A	Gutter Slope (%)	N/A
N/A	Gutter Lip Ht (in)	N/A	N/A	Gutter X Slope (%)	N/A
N/A	Painted X Walk1?	No	N/A	Painted X Walk2?	N/A
	X Walk 1 Direction	To NW		X Walk 2 Direction	N/A
N/A	X Walk 1 Width (in)	N/A	N/A	X Walk 2 Width (in)	N/A
	X Walk 1 Slope (%)	0.1		X Walk 2 Slope (%)	N/A
	X Walk 1 X Slope (%)	0.7		X Walk 2 X Slope (%)	N/A

Possible Solutions:

Remove & Replace Entire Ramp.

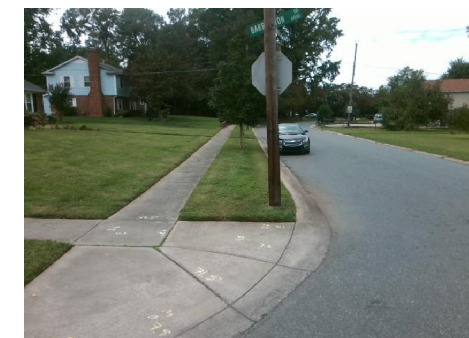
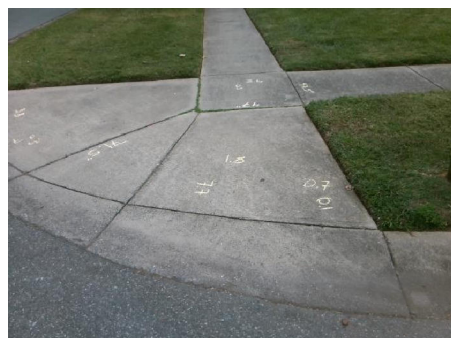
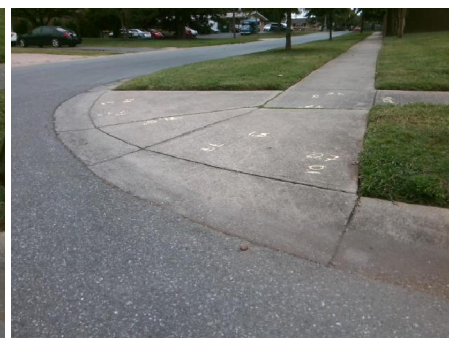
N/A	Ramp inside XWalk1?	N/A	N/A	Ramp inside XWalk2?	N/A
	Road Slope (%)	N/A	N/A	Clear Space?	N/A
	Road X Slope (%)	N/A	N/A	Clear Space to XWalk (in)	N/A
N/A	Any Obstructions?	N/A	N/A	Storm Grate/Utility Hazard?	N/A
	Obstruction Type			Storm Grate/Utility Type	
		N/A			N/A
			Yes	Surface Condition? (G/P)	Good
