# Access Compliance Report

## Public Rights-of-Way

### (Curb Ramps)

Intersection ID: 19496	Main Street: CRANFORD_DR	Cross Street: PARK_RD	Location: SW
ADA ID: 85884E524102	Ramp Type: Perp	Initial Pass/Fail: Fail	Overall Compliance: No
			Severity Score: 13.75

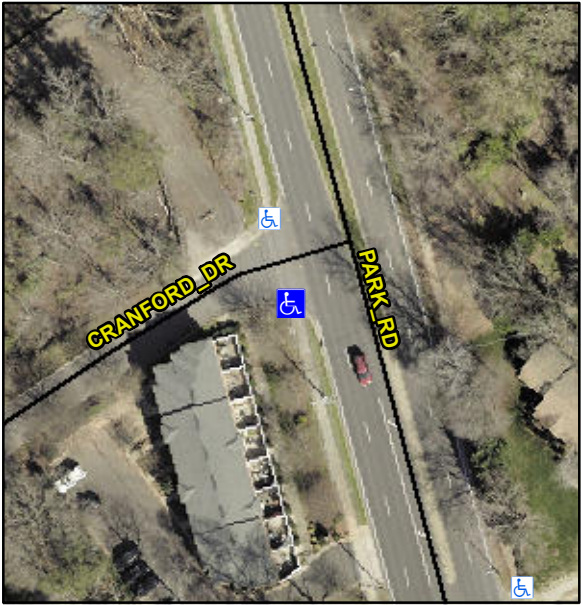
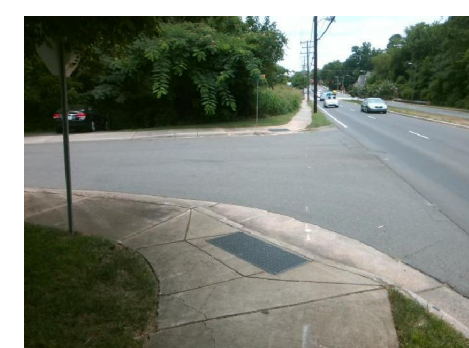
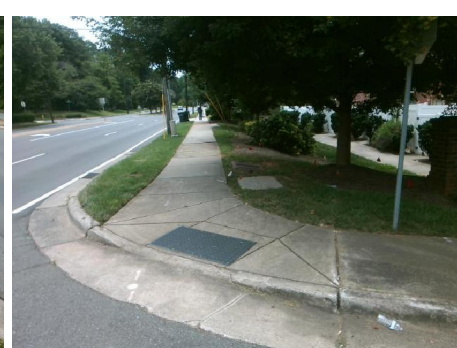
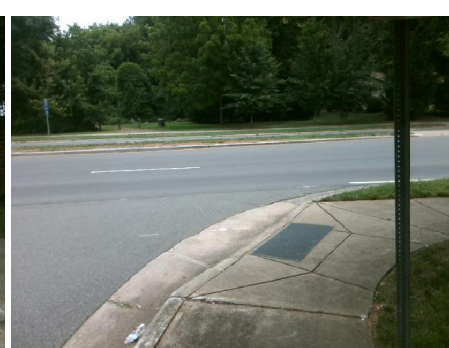
Possible Solutions:		<b>Compliance</b>	<b>Description</b>	<b>Data</b>
	<b>Remove &amp; Replace Entire Ramp.</b>		<b>No</b>	Ramp Length (in)	71.0
			<b>Yes</b>	Ramp Width (in)	48.0
			<b>N/A</b>	Flare Type LT	N/A
			<b>N/A</b>	Flare Slope LT (%)	N/A
			<b>N/A</b>	Flare Traversable LT?	N/A
			<b>N/A</b>	Landing Length (in)	N/A
			<b>N/A</b>	Landing Width (in)	N/A
			<b>N/A</b>	Landing Slope (%)	N/A
			<b>N/A</b>	Landing X Slope (%)	N/A
<p>Surveyor Notes:</p> <p><b>N/A</b></p> <p>PROW/ADA:</p> <p><b>Not Found, R304.2.2, R304.5.3</b></p>			<b>N/A</b>	Flare Type RT	N/A
			<b>N/A</b>	Flare Slope RT (%)	N/A
			<b>N/A</b>	Flare Traversable RT?	N/A
			<b>N/A</b>	DWS Provided?	N/A
			<b>N/A</b>	DWS Contrast?	N/A
			<b>N/A</b>	DWS Length (in)	N/A
			<b>N/A</b>	DWS Full Width?	N/A
			<b>N/A</b>	DWS Offset (in)	N/A
			<b>N/A</b>	Shared Landing?	N/A

<b>N/A</b>	Gutter Ponding?	N/A
			<b>N/A</b>	Gutter Lip Ht (in)	N/A
			<b>N/A</b>	Painted X Walk1?	No
				X Walk 1 Direction	To N
			<b>N/A</b>	X Walk 1 Width (in)	N/A
				X Walk 1 Slope (%)	5.4
				X Walk 1 X Slope (%)	4.2
			<b>N/A</b>	Ramp inside XWalk1?	N/A
			<b>N/A</b>	Road Slope (%)	N/A
			<b>N/A</b>	Road X Slope (%)	N/A
			<b>N/A</b>	Any Obstructions?	N/A
Total Cost:		\$ 1850.00		Obstruction Type	
			<b>N/A</b>		
			<b>Yes</b>	Surface Condition? (G/P)	Good
