# Access Compliance Report

## Public Rights-of-Way

### (Curb Ramps)

Intersection ID: 8600	Main Street: NEWELL_ACRES_DR	Cross Street: NEWELL-HICKORY_GROVE_RD	Location: SW
ADA ID: 858DFC7CCEB0	Ramp Type: Perp	Initial Pass/Fail: Fail	Overall Compliance: No
Severity Score: 37.5			
Codes/Mitigation Info/Possible Solution		Field Measurements/Component Compliance

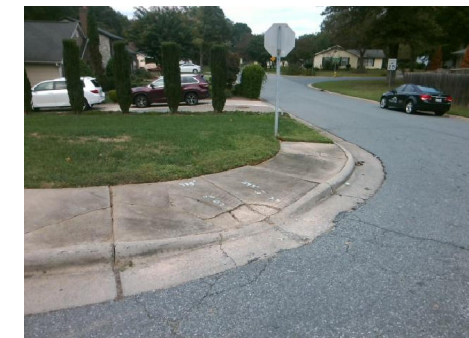
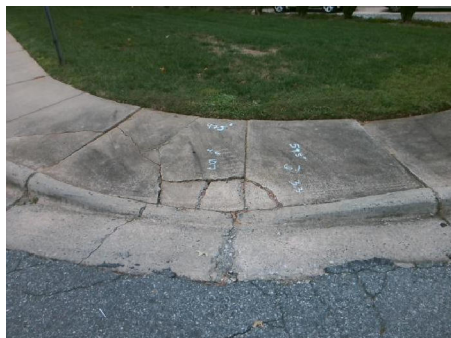
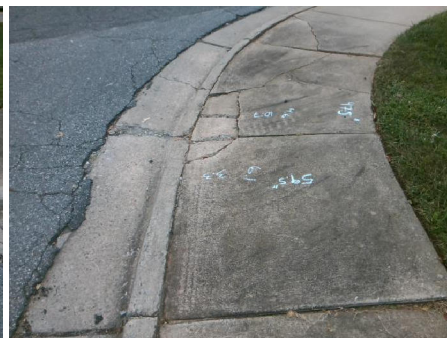
Compliance	Description	Data	Compliance	Description	Data
N/A	Ramp Length (in)	59.5	No	Ramp Slope (%)	10.7
No	Ramp Width (in)	47.5	No	Ramp XSlope (%)	4.6
N/A	Flare Type LT	N/A	N/A	Flare Type RT	N/A
N/A	Flare Slope LT (%)	N/A	N/A	Flare Slope RT (%)	N/A
N/A	Flare Traversable LT?	N/A	N/A	Flare Traversable RT?	N/A
N/A	Landing Length (in)	N/A	N/A	DWS Provided?	N/A
N/A	Landing Width (in)	N/A	N/A	DWS Contrast?	N/A
N/A	Landing Slope (%)	N/A	N/A	DWS Length (in)	N/A
N/A	Landing X Slope (%)	N/A	N/A	DWS Full Width?	N/A
N/A	Landing Curb? (Y/N)	N/A	N/A	DWS Offset (in)	N/A
N/A	Shared Landing?	N/A			
N/A	Gutter Ponding?	N/A	N/A	Gutter Slope (%)	N/A
N/A	Gutter Lip Ht (in)	1.5	N/A	Gutter X Slope (%)	N/A
N/A	Painted X Walk1?	No	N/A	Painted X Walk2?	N/A
	X Walk 1 Direction	To N		X Walk 2 Direction	N/A
N/A	X Walk 1 Width (in)	N/A	N/A	X Walk 2 Width (in)	N/A
	X Walk 1 Slope (%)	3.3		X Walk 2 Slope (%)	N/A
	X Walk 1 X Slope (%)	6.1		X Walk 2 X Slope (%)	N/A

N/A	Ramp inside XWalk1?	N/A	N/A	Ramp inside XWalk2?	N/A
	Road Slope (%)	N/A	N/A	Clear Space?	N/A
	Road X Slope (%)	N/A	N/A	Clear Space to XWalk (in)	N/A
N/A	Any Obstructions?	N/A	N/A	Storm Grate/Utility Hazard?	N/A
	Obstruction Type			Storm Grate/Utility Type	
		N/A			N/A
		No		Surface Condition? (G/P)	Poor

Possible Solutions:

**Remove & Replace Entire Ramp.**
