# Access Compliance Report

## Public Rights-of-Way

### (Curb Ramps)

Intersection ID: 5520	Main Street: CARVER_BV	Cross Street: WASHINGTON_PL	Location: W
ADA ID: 859525C9FDE2	Ramp Type: Para	Initial Pass/Fail: Fail	Overall Compliance: No
			Severity Score: 31.25

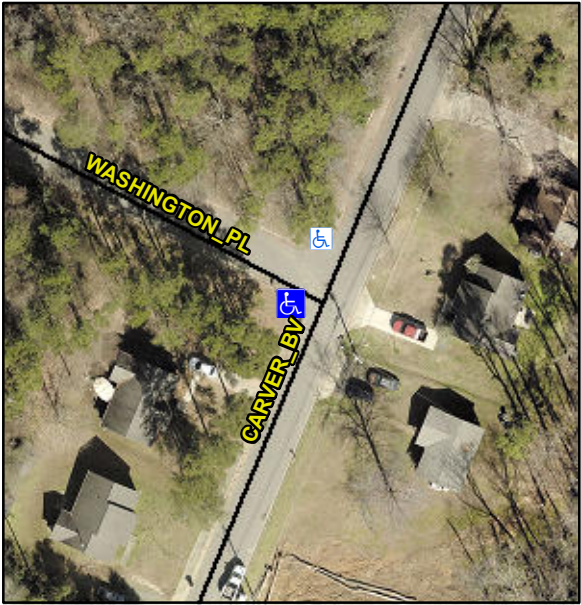
Possible Solutions:		<b>Compliance</b>	<b>Description</b>	<b>Data</b>
	<b>Remove &amp; Replace Entire Ramp.</b>		<b>N/A</b>	Ramp Length LT (in)	<b>40.0</b>
			<b>No</b>	Ramp Width LT (in)	<b>34.0</b>
			<b>No</b>	Ramp Slope LT (%)	<b>11.3</b>
			<b>No</b>	Ramp XSlope LT (%)	<b>2.6</b>
			<b>N/A</b>	Landing Length (in)	<b>N/A</b>
			<b>N/A</b>	Landing Width (in)	<b>N/A</b>
			<b>N/A</b>	Landing Slope (%)	<b>N/A</b>
			<b>N/A</b>	Landing X Slope (%)	<b>N/A</b>
			<b>N/A</b>	Landing Curb? (Y/N)	<b>N/A</b>
<p>Surveyor Notes:</p> <p><b>N/A</b></p> <p>PROW/ADA:</p> <p><b>R304.5.1, R304.3.2, R304.5.3</b></p>			<b>N/A</b>	Shared Landing?	<b>N/A</b>
			<b>N/A</b>	Gutter Ponding?	<b>N/A</b>
			<b>N/A</b>	Gutter Lip Ht (in)	<b>N/A</b>
			<b>N/A</b>	Painted X Walk1?	<b>No</b>
				X Walk 1 Direction	<b>To N</b>
			<b>N/A</b>	X Walk 1 Width (in)	<b>N/A</b>

X Walk 1 Slope (%)	<b>0.6</b>
				X Walk 1 X Slope (%)	<b>0.1</b>
			<b>N/A</b>	Ramp inside XWalk1?	<b>N/A</b>
				Road Slope (%)	<b>N/A</b>
			<b>N/A</b>	Road X Slope (%)	<b>N/A</b>
			<b>N/A</b>	Any Obstructions?	<b>N/A</b>
				Obstruction Type	
			<b>N/A</b>		<b>N/A</b>
			<b>Yes</b>	Surface Condition? (G/P)	<b>Good</b>
			<b>N/A</b>	Curb Slope (%)	<b>14.5</b>
Total Cost:		\$ 1600.00
