Access Compliance Report

Public Rights-of-Way

(Curb Ramps)

Intersection ID: 50736	Main Street: JONES RIDGE DR	Cross Street: PROVIDENCE LN WEST	Location: E
ADA ID: 85A4D1EBBD70	Ramp Type: PerpDiag	Initial Pass/Fail: Fail	Overall Compliance: No
Severity Score: 12.5			
Codes/Mitigation Info/Possible Solution		Field Measurements/Component Compliance

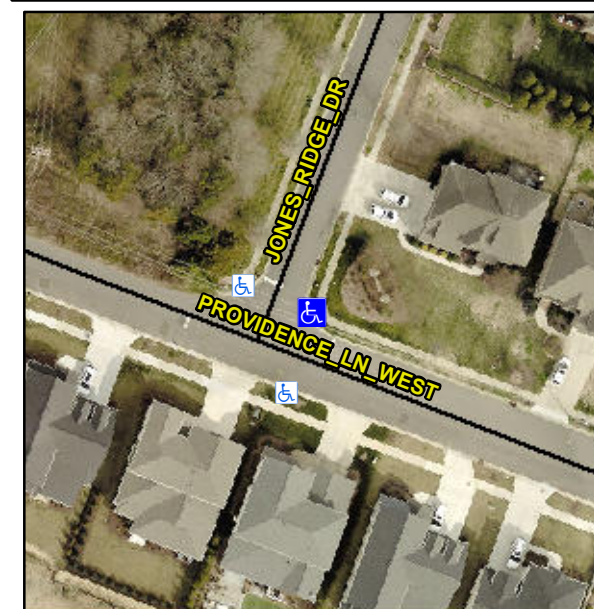
Not Found, R304.5.3

Compliance	Description	Data	Compliance	Description	Data
N/A	Ramp Length (in)	96.0	Yes	Ramp Slope (%)	5.7
Yes	Ramp Width (in)	48.0	No	Ramp XSlope (%)	5.9
N/A	Flare Type LT	N/A	N/A	Flare Type RT	N/A
N/A	Flare Slope LT (%)	N/A	N/A	Flare Slope RT (%)	N/A
N/A	Flare Traversable LT?	N/A	N/A	Flare Traversable RT?	N/A
N/A	Landing Length (in)	N/A	N/A	DWS Provided?	N/A
N/A	Landing Width (in)	N/A	N/A	DWS Contrast?	N/A
N/A	Landing Slope (%)	N/A	N/A	DWS Length (in)	N/A
N/A	Landing X Slope (%)	N/A	N/A	DWS Full Width?	N/A
N/A	Landing Curb? (Y/N)	N/A	N/A	DWS Offset (in)	N/A
N/A	Shared Landing?	N/A			
N/A	Gutter Ponding?	N/A	N/A	Gutter Slope (%)	N/A
N/A	Gutter Lip Ht (in)	N/A	N/A	Gutter X Slope (%)	N/A
N/A	Painted X Walk1?	No	N/A	Painted X Walk2?	No
	X Walk 1 Direction	To NW		X Walk 2 Direction	To SW
N/A	X Walk 1 Width (in)	N/A	N/A	X Walk 2 Width (in)	N/A
	X Walk 1 Slope (%)	4.2		X Walk 2 Slope (%)	2.1
	X Walk 1 X Slope (%)	5.0		X Walk 2 X Slope (%)	3.3

N/A	Ramp inside XWalk1?	N/A	N/A	Ramp inside XWalk2?	N/A
	Road Slope (%)	5.5	N/A	Clear Space?	N/A
	Road X Slope (%)	0.7	N/A	Clear Space to XWalk (in)	N/A
N/A	Any Obstructions?	N/A	N/A	Storm Grate/Utility Hazard?	N/A
	Obstruction Type			Storm Grate/Utility Type	
		N/A			N/A
		Yes		Surface Condition? (G/P)	Good

Possible Solutions:

Remove & Replace Curb Ramp With Two New Directional Ramps or Equivalent.
