Access Compliance Report

Public Rights-of-Way

(Curb Ramps)

Intersection ID: 2710	Main Street: FAIRVISTA_DR	Cross Street: QUEENSBURY_CT	Location: SE
ADA ID: 85AAD88A8A1E	Ramp Type: PerpDiag	Initial Pass/Fail: Fail	Overall Compliance: No
Severity Score: 8.75			
Codes/Mitigation Info/Possible Solution		Field Measurements/Component Compliance

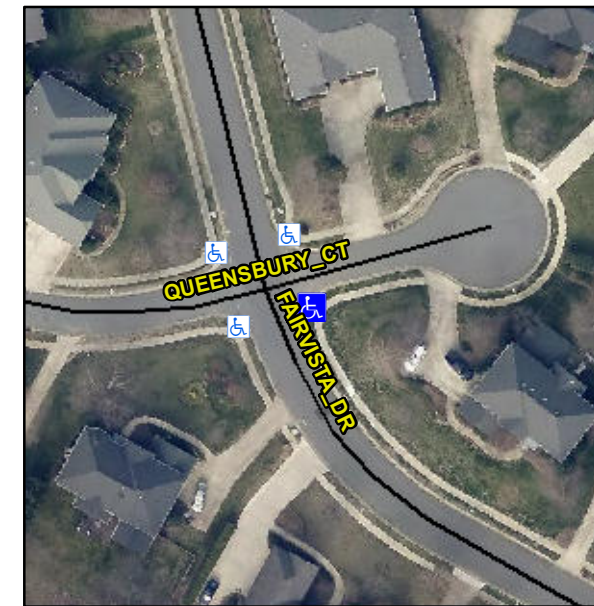
Not Found, R304.5.1

Compliance	Description	Data	Compliance	Description	Data
N/A	Ramp Length (in)	44.0	Yes	Ramp Slope (%)	7.2
No	Ramp Width (in)	45.0	Yes	Ramp XSlope (%)	0.2
N/A	Flare Type LT	N/A	N/A	Flare Type RT	N/A
N/A	Flare Slope LT (%)	N/A	N/A	Flare Slope RT (%)	N/A
N/A	Flare Traversable LT?	N/A	N/A	Flare Traversable RT?	N/A
N/A	Landing Length (in)	N/A	N/A	DWS Provided?	N/A
N/A	Landing Width (in)	N/A	N/A	DWS Contrast?	N/A
N/A	Landing Slope (%)	N/A	N/A	DWS Length (in)	N/A
N/A	Landing X Slope (%)	N/A	N/A	DWS Full Width?	N/A
N/A	Landing Curb? (Y/N)	N/A	N/A	DWS Offset (in)	N/A
N/A	Shared Landing?	N/A			
N/A	Gutter Ponding?	N/A	N/A	Gutter Slope (%)	N/A
N/A	Gutter Lip Ht (in)	N/A	N/A	Gutter X Slope (%)	N/A
N/A	Painted X Walk1?	No	N/A	Painted X Walk2?	No
	X Walk 1 Direction	To N		X Walk 2 Direction	To W
N/A	X Walk 1 Width (in)	N/A	N/A	X Walk 2 Width (in)	N/A
	X Walk 1 Slope (%)	3.0		X Walk 2 Slope (%)	2.1
	X Walk 1 X Slope (%)	0.8		X Walk 2 X Slope (%)	0.2

N/A	Ramp inside XWalk1?	N/A	N/A	Ramp inside XWalk2?	N/A
	Road Slope (%)	0.5	N/A	Clear Space?	N/A
	Road X Slope (%)	1.9	N/A	Clear Space to XWalk (in)	N/A
N/A	Any Obstructions?	N/A	N/A	Storm Grate/Utility Hazard?	N/A
	Obstruction Type			Storm Grate/Utility Type	
		N/A			N/A
		Yes		Surface Condition? (G/P)	Good

Remove & Replace Curb Ramp With Two New Directional Ramps or Equivalent.
