# Access Compliance Report

## Public Rights-of-Way

### (Curb Ramps)

Intersection ID: 2932	Main Street: GREEN_HEDGE_AV	Cross Street: WINTER_PINE_LN	Location: NW
ADA ID: 85E234368DBD	Ramp Type: Perp	Initial Pass/Fail: Fail	Overall Compliance: No
			Severity Score: 21.25

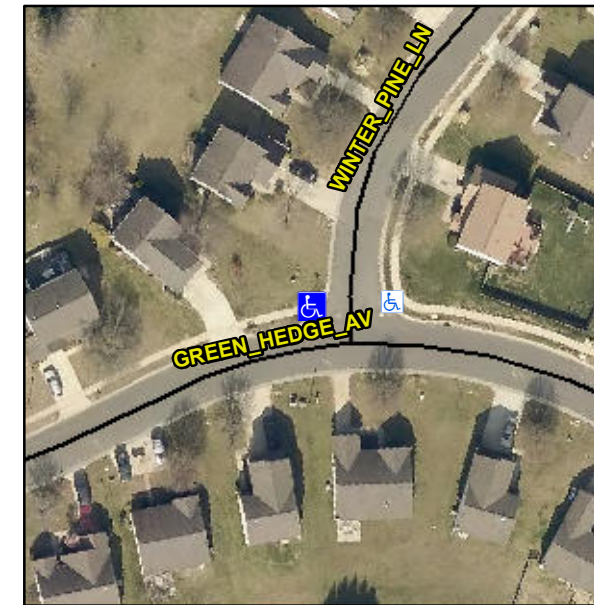
**Not Found, R304.5.1, R304.2.2**

Compliance	Description	Data	Compliance	Description	Data
N/A	Ramp Length (in)	49.0	No	Ramp Slope (%)	10.8
No	Ramp Width (in)	38.0	Yes	Ramp XSlope (%)	1.6
N/A	Flare Type LT	N/A	N/A	Flare Type RT	N/A
N/A	Flare Slope LT (%)	N/A	N/A	Flare Slope RT (%)	N/A
N/A	Flare Traversable LT?	N/A	N/A	Flare Traversable RT?	N/A
N/A	Landing Length (in)	N/A	N/A	DWS Provided?	N/A
N/A	Landing Width (in)	N/A	N/A	DWS Contrast?	N/A
N/A	Landing Slope (%)	N/A	N/A	DWS Length (in)	N/A
N/A	Landing X Slope (%)	N/A	N/A	DWS Full Width?	N/A
N/A	Landing Curb? (Y/N)	N/A	N/A	DWS Offset (in)	N/A
N/A	Shared Landing?	N/A			
N/A	Gutter Ponding?	N/A	N/A	Gutter Slope (%)	N/A
N/A	Gutter Lip Ht (in)	N/A	N/A	Gutter X Slope (%)	N/A
N/A	Painted X Walk1?	No	N/A	Painted X Walk2?	N/A
	X Walk 1 Direction	To E		X Walk 2 Direction	N/A
N/A	X Walk 1 Width (in)	N/A	N/A	X Walk 2 Width (in)	N/A
	X Walk 1 Slope (%)	0.5		X Walk 2 Slope (%)	N/A
	X Walk 1 X Slope (%)	0.0		X Walk 2 X Slope (%)	N/A

N/A	Ramp inside XWalk1?	N/A	N/A	Ramp inside XWalk2?	N/A
	Road Slope (%)	N/A	N/A	Clear Space?	N/A
	Road X Slope (%)	N/A	N/A	Clear Space to XWalk (in)	N/A
N/A	Any Obstructions?	N/A	N/A	Storm Grate/Utility Hazard?	N/A
	Obstruction Type			Storm Grate/Utility Type	
		N/A			N/A
			Yes	Surface Condition? (G/P)	Good

**Remove & Replace Entire Ramp.**
